CAPITAL ASSESSMENT REPORT: Water Treatment and Distribution System

TOWN OF RIDGWAY

Final Report
May 21, 2019

Prepared by:
Consolidated Consulting Services

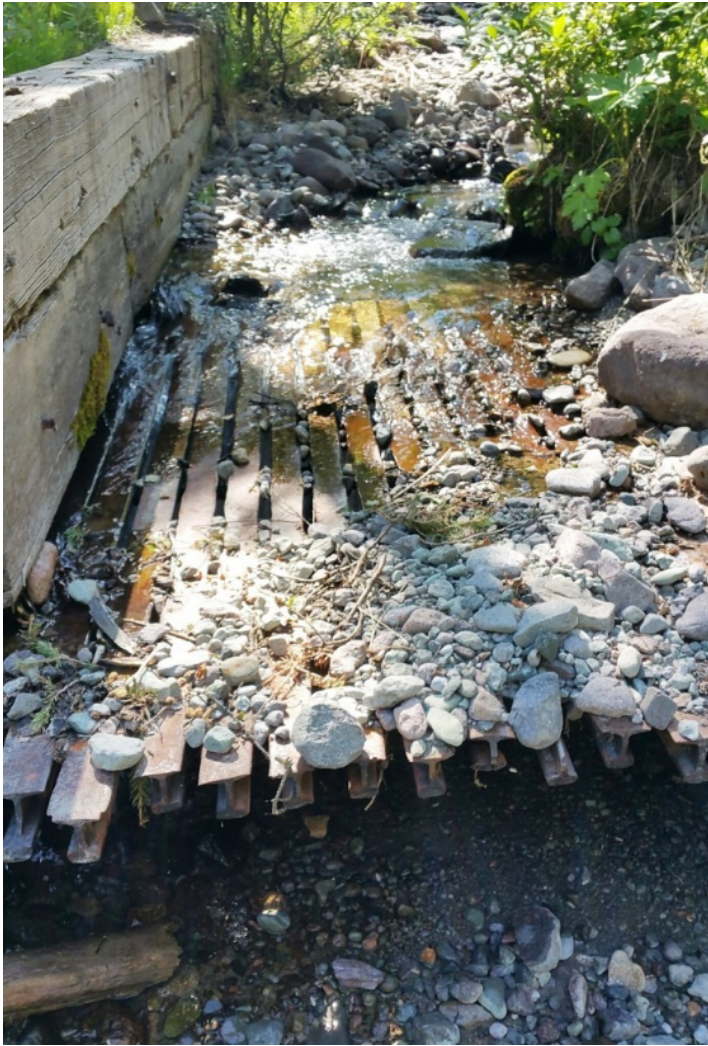
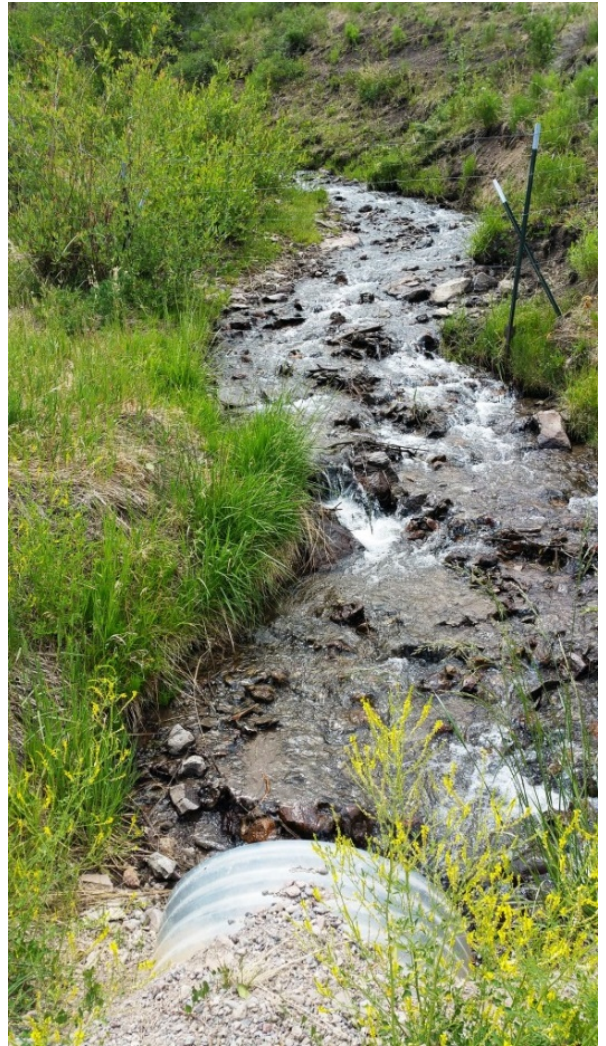
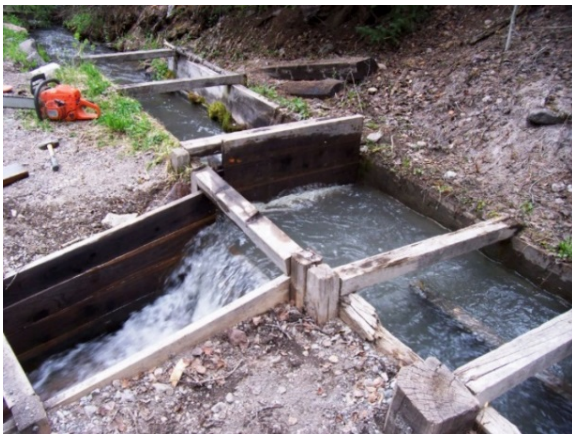
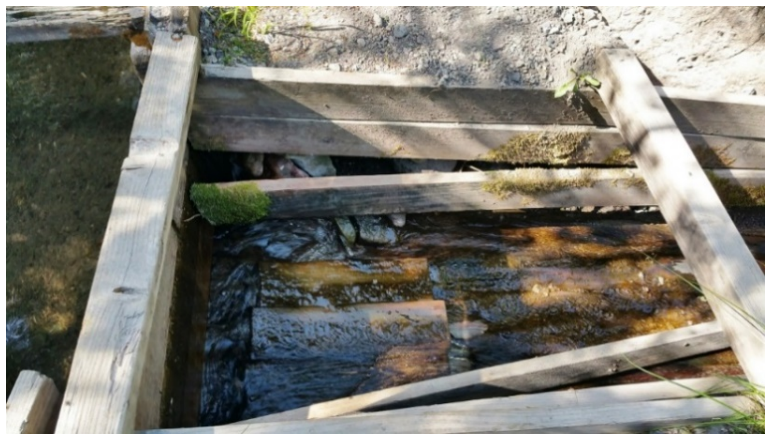
At the Beaver Creek diversion, the Town diverts the water from Beaver Creek into a side channel that runs the water over a “grizzly”, which screens out the larger rocks and some debris and into a trough. The first section of the trough includes a swing gate that can either direct the water directly into the Ridgway Ditch and/or divert some or all of the flow into a side channel that serves as both an overflow and rock chute. Spring water is also diverted into the Ridgway Ditch in various locations.

The old trough was likely constructed in the mid to late 1970's is largely made of what was rough sawn lumber. The photos on page 11 show some of the reasons the trough was rated yond its useful life. The wood on the floor of the trough had been worn down by the rocks and gravel running over the wood. Large storm events and time have allowed water to get behind the trough and time also caused the wood to warp. The old trough was replaced in the fall of 2018. The new trough is about 40% larger capacity to about 10 cfs, using a conservative n-value of about 0.03, which is far more than the capacity of the Ridgway Ditch (about 4 cfs in the most restricted areas of the ditch?). The rock chute was designed to work as both a rock chute and overflow channel. The existing chute which already has a capacity of about 20 cfs, is now increased to about 25 cfs. The design for the new trough is included in the appendices. This new design should have a 50-year life.

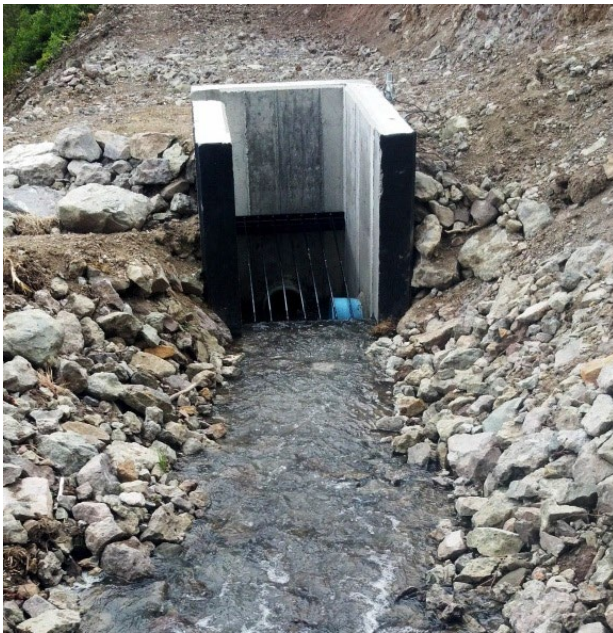
The transmission line from Lake O to the pre-sedimentation ponds above the water plant was constructed in about 1980. The first 20 feet of pipe is 12", then 20' of 10" and then most of the pipe is 8" with some 10" in the flatter sections of the line. Except for approximately the bottom 1850 ft of pipe, which is ductile iron, almost all the rest of pipe is SDR 26 Class 160 PVC pipe limiting the pressures the pipes can handle.

Water can be directed to the transmission pipe directly from the Ridgway Ditch below the Lake O saddle (as it was in the recent past) or can come from the pipe from the Lake through the saddle on the northwest side of the Lake. The new structure that accommodates flows from both directions (the Ridgway Ditch and Lake O) is shown at left. The blue pipe is coming from the Lake and the water seen flowing into the box is from the Ridgway Ditch. There is a bar screen to screen the water from the Ditch at this structure and a bar screen on the inlet to the pipe from the Lake. The structure also includes an overflow weir in case the transmission line becomes blocked. The Town replaced the upstream 20 feet or so of pipe with 12" diameter C900 pipe in 2015.

As part of the Lake O project, the existing 12" pipe at the Lake outfall was replaced with C900 and about 20' of additional 12" pipe was extended to the new outfall box at the Lake. The Town has not had issues with the line so it is assumed to be in good condition. Should the Town decide to build pressure up in the line for micro-hydro or other reasons, the condition of the pipe should be investigated in more detail in terms of its condition its pressure rating and its frost protection.

There have also been a few issues with the air vacs in that area and a thorough inspection of the air vac valves on the full transmission line is recommended. They could be approaching the end of their useful life and some may need to be replaced in the coming years. The existing PVC pipe especially since it is not under pressure is expected to have a life span of about 80 years or even longer. A Unibell Pipe Association report entitled "Life Cycle Assessment of PVC Water and Sewer Pipe and Comparative Sustainability Analysis of Pipe Materials" references a lift expectancy of in excess of 100 years.

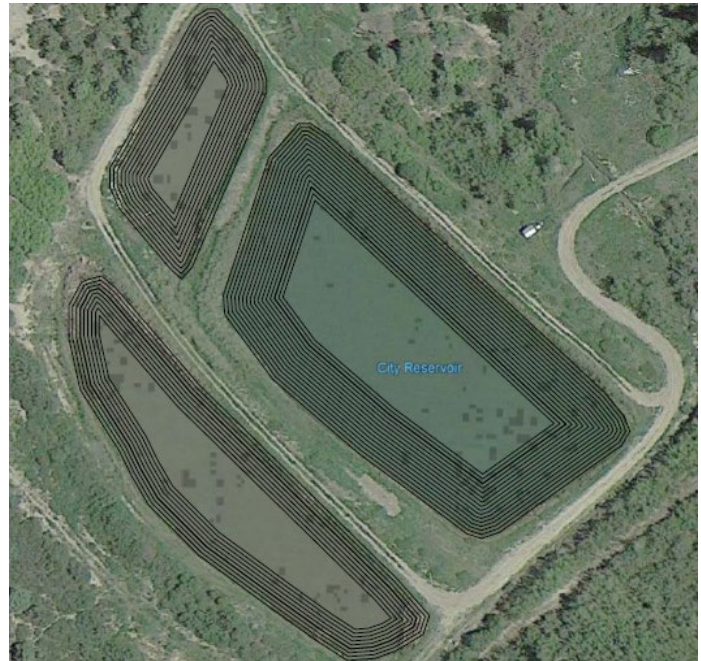
The 1980 drawings for the water system have an aerial photo of the pre-sedimentation ponds, but no volumes or depths. To determine the volume for this assessment, a scaled google earth image of the ponds was inserted into cad and the rough area of the high-water line was determined. The slopes were assumed to be 3:1 slope and the upper pond was assumed to be 8' deep which results in a volume of about 1.25 MG, the big pond was assumed to be 12' deep which results in a volume of about 3.4 MG and the small pond about 8' deep with a volume of about 0.5 MG and an overall volume of all ponds combined about 5.15 MG. If the assumptions about the slopes or depths are modified, the assumed volumes would change as they would if the surface area assumptions change. With a current peak demand of about 0.375 MGD treated and non-potable demand of about 0.5 cfs (0.323 MGD), detention time through the pre-sedimentation ponds in the summer is about 7.3 days.

As the Town's water demand increases, the detention time of the water in the ponds will decrease. It will also decrease if sediment increases. If total (potable and non-potable) water demand increases 50% in the next two decades, detention time in the pre-sedimentation ponds would drop to about 4.9 days in the summer if the current capacity is not reduced due to sediment build up. Given that most of the sediment seems to accumulate in the first part of the upper pond and the Town at times able to remove some of the accumulation, the reduction in detention time due to sediment may not be problematic in the next 10-15 years or so. Longer term, the Town might want to consider renovating the ponds. The pond area is mostly land locked with the ponds occupying most of the Town-owned land and they are also a bit topographically constrained in that there is a steep slope on the upstream side of the upper pond and a steep drop off the lower side of the big ponds. The most practical solution for expansion may be to increase the height of the dam southwest of the water plant and maybe to combine the larger and small pond. Options for renovation and capacity should be evaluated in greater detail when additional capacity is needed.

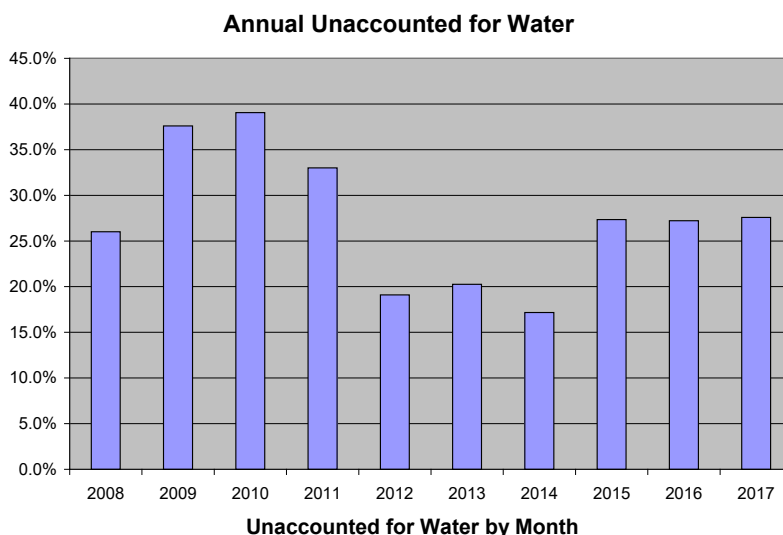
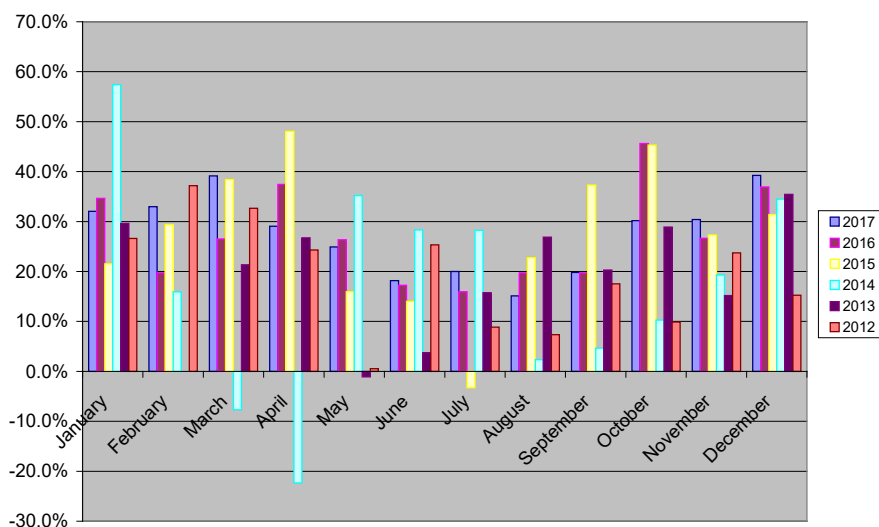
Unaccounted for water is the difference between the water produced and the water sold. Until the drought in 2002, the generally accepted range in Colorado for unaccounted for water was in the 20% range which dated back to a time when water lines were less tight. Since the drought in the early 2000's, and as it has become more obvious that there is a limit to the water resources in the State, the State has been encouraging communities to reduce the unaccounted for water rate to 10% or less.

The upper bar chart above shows the unaccounted for water by year. The annual assessment is likely more representation of the differences between produced and sold because it smooths out the differences between what day in the month meters are read versus the water produced. The annual chart shows that

there were several years where the unaccounted for water was in excess of 30%, then several years where it was 15-20% and the last few years have all been above 25%. The lower bar chart shows the unaccounted for water by month over several years. Although there is large variability, in general, it looks like in the summer months, the unaccounted for water is less than in the winter. This might be the result of both producing and selling more water in the summer making the percent look lower.
