Technical Report

River Channel Characteristics of the Uncompahgre River in Ridgway, CO

SUBMITTED: 12/3/2021

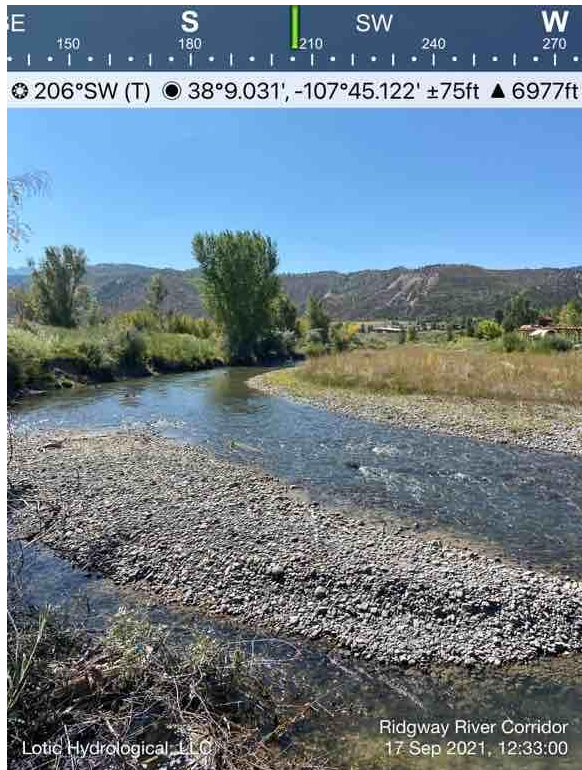
Photo point # 4. Upstream of the CO 62 Bridge looking south. The channel is sometimes multi-threaded, but exhibits many typical characteristics of meandering rivers including point bar development opposed by a cutbank form on the opposite bank. Some larger woody riparian vegetation communities (willows, cottonwood) exist on the east bank, while early successional vegetation (grasses) have colonized the point bar on the west bank.

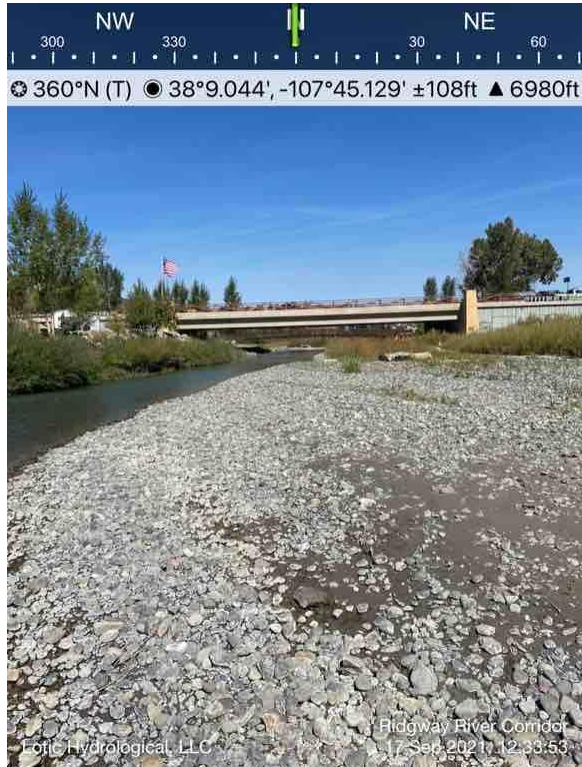
Photo point # 45. Upstream of the CO 62 Bridge looking north. A long slender bar is deposited from the east bank into the center of the river just upstream of the highway bridge constriction.

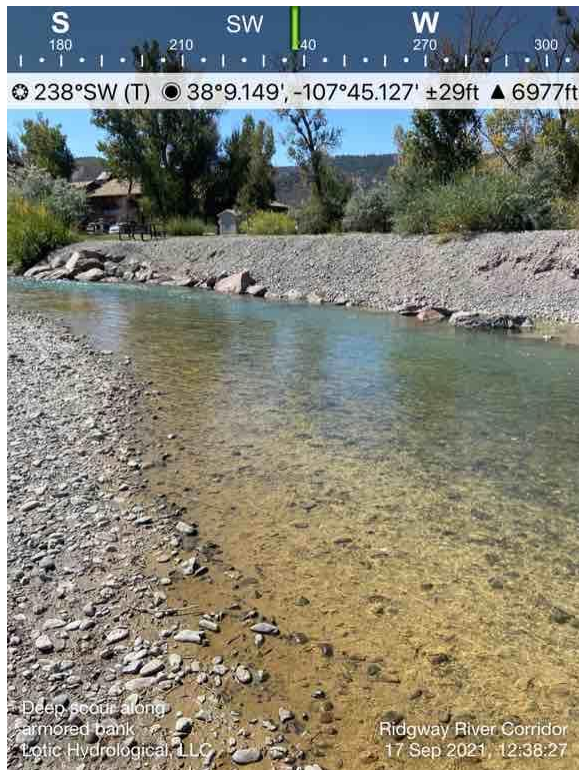
Photo point # 10. Downstream of whitewater park looking SW. Large boulders likely placed for bank protection have been undercut by deep scouring below a bare gravel bank slope. Because this is the outside of a meander bend that is currently opposed by an actively growing point bar, a cutbank is an expected geomorphic form. However, the small/medium clast sizes of floodplain substrates coupled with the area's prior history of gravel mining and vegetation alteration means the bank in this location has little competence to resist shear stress forces.

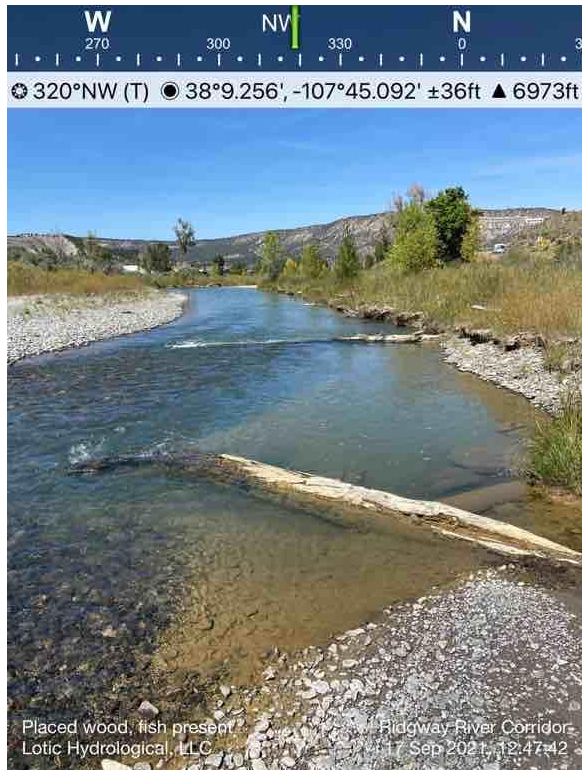
Photo point # 18. Looking NW at the downstream end of the railroad museum open space. Placed logs functioning as lateral vanes or barbs are still present, although the bank anchoring stability is beginning to degrade. Because this is the outside of a channel bend, a cutbank on the right bank is an expected form as shear stresses during high flows pile against the channel margin. Further establishment of native woody vegetation on the currently grassy banks may slow channel migration. The logs continue to maintain some in-channel habitat heterogeneity.

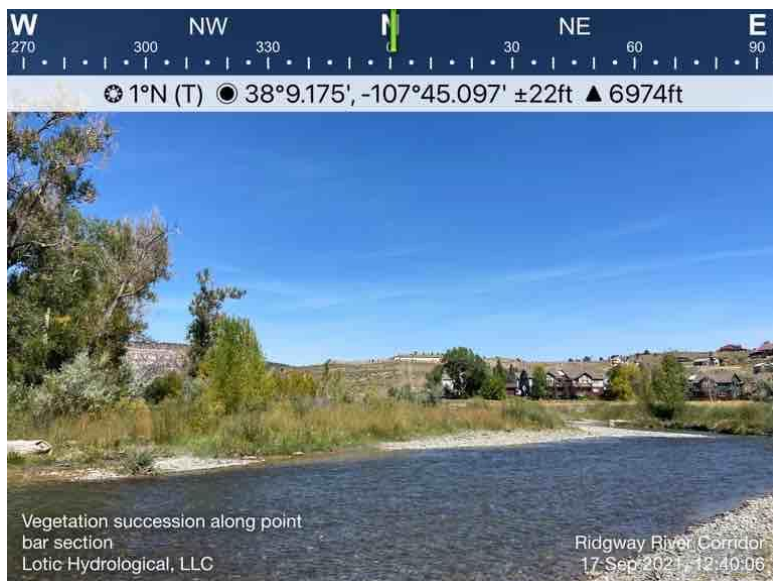
Photo point # 17. Looking west at the railroad museum open space. Multiple successional stages of riparian vegetation indicate functional community processes are in place.

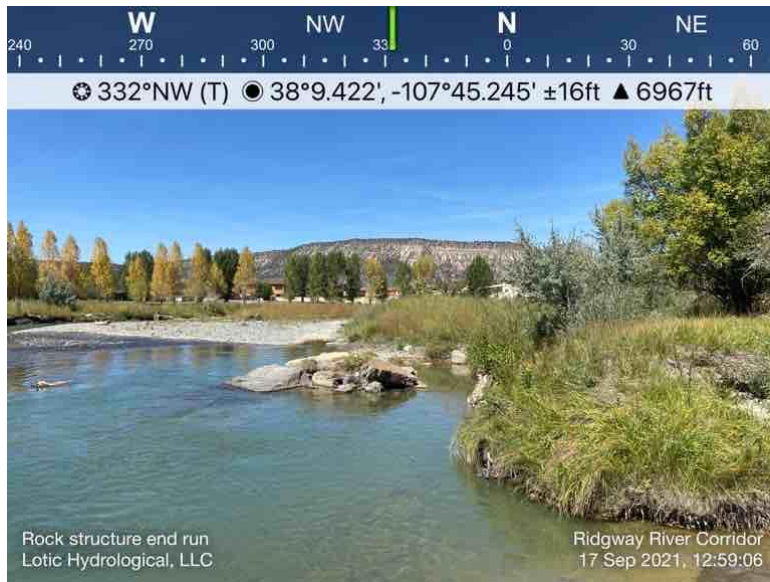
Photo point # 26. Looking NW towards the N Railroad St turn and San Miguel Power campus.

The river has performed an end-run around a placed rock structure during high flows, scouring a new channel laterally around the outside of the structure.

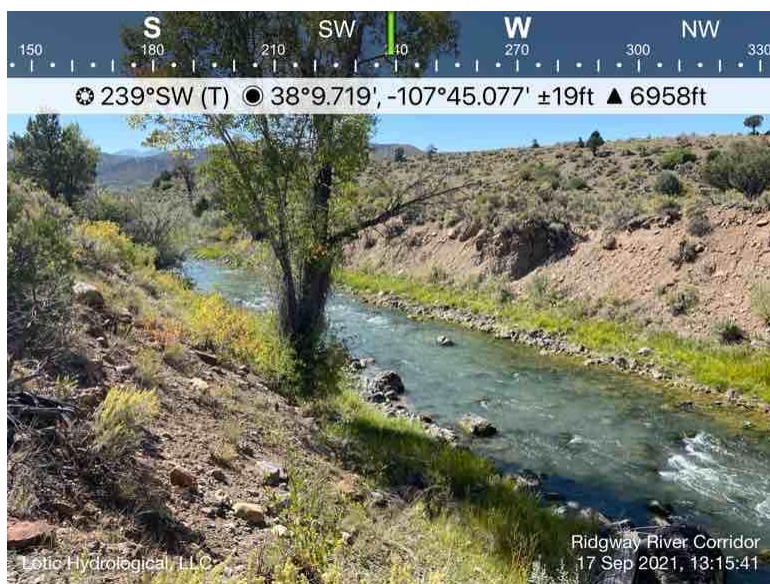
Photo point # 38. Looking SW back upstream towards the recreation path bridge. The confined river corridor is resilient to channel changes, with a narrow riparian strip and heterogenous in-channel clast sizes.

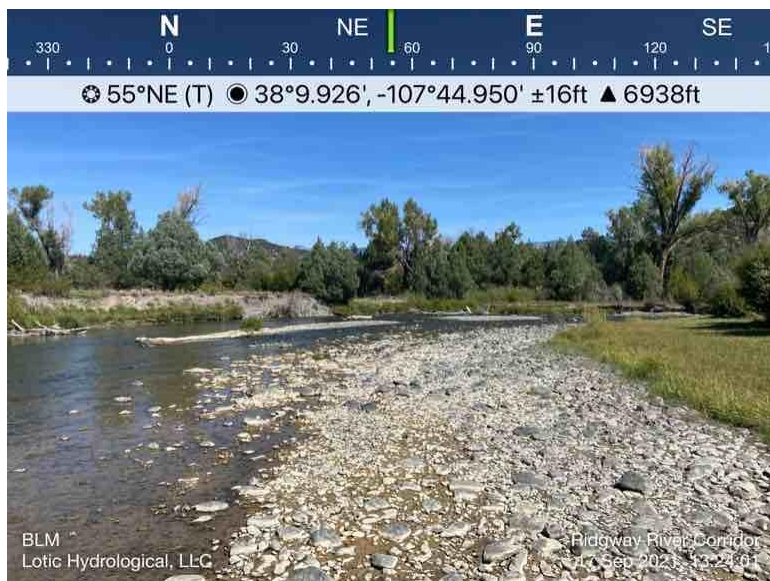
Photo point # 41. Looking NE downstream towards Dennis Weaver Park areas. Subtle armoring and/or slight imbrication of clasts on this point bar or lateral bar form indicate this reach may not experience the transport-limited conditions apparent in reaches upstream.

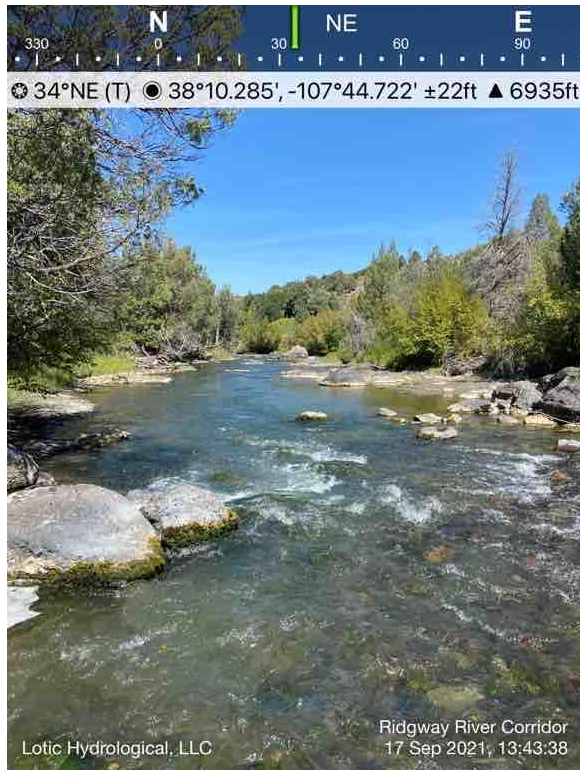
Photo point # 51. Looking NE downstream near the northern boundary of Dennis Weaver Park near the town's municipal boundary. Large and heterogeneous in-channel substrates provide a diverse aquatic habitat patchwork. Narrow but vibrant riparian communities transition rapidly to upland plant species in this confined channel zone.

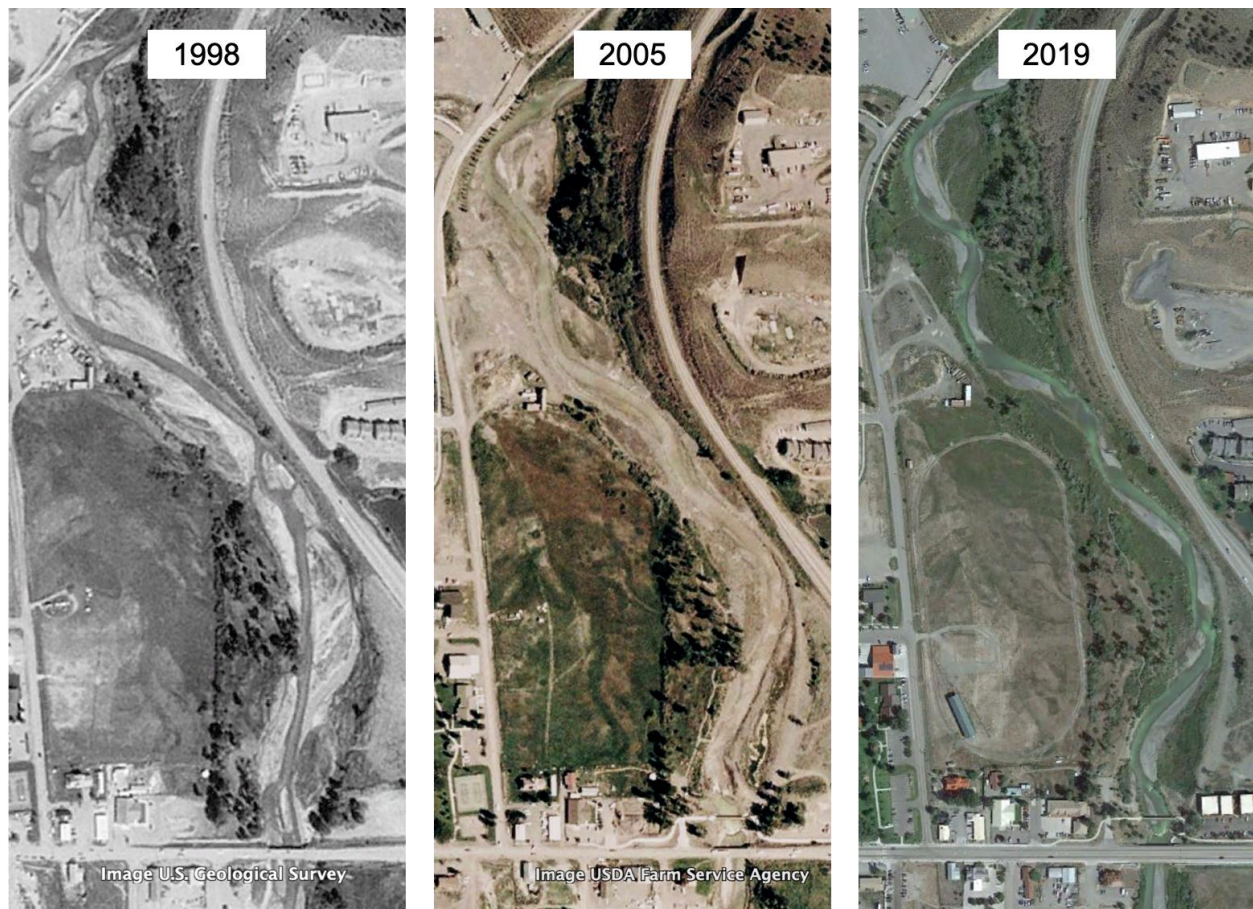
Figure 6. Channel evolution downtown, pre/post restoration and current conditions.

Inspection of channel characteristics including curve radius, vegetated riparian and floodplains zones, and especially; in-channel bar features and types, suggest the river may be trying to re-establish a more wandering gravel bed style planform within its channel migration zone rather than remaining a single-thread. For example, rather than consistent growing point bar growth, the channel is readily dissecting newer point bars with multiple cutoff channels, similar to a diagonal bar. Confining terraces and constraints on meandering imposed by the highway to the east and downtown road and parking lot infrastructure on the west bank also contribute the inability of a fully-meandering pattern to develop and maintain itself in a stable form over extended time period. If a single-thread channel is in fact the historical

natural type, it also appears that the floodplain widths available in the town reach for the meanders to form and evolve are simply too narrow between Railroad Drive and Highway 550. As a result, within the lateral active channel and floodplain widths available in the downtown area for the channel to migrate and meander, a single-threaded channel may not be a self-sustaining form over relevant human time scales (decades).
