**Ridgway Town Council  
Special Meeting Agenda  
Monday, June 2, 2025**

1. Review, Discussion and Direction on ***Existing Conditions & Alternatives Analysis for the Beaver Creek Diversion Restoration Project***

# EXTERNAL MEMORANDUM

**Subject:** Existing Conditions & Alternatives Analysis  
Beaver Creek Diversion Restoration Project

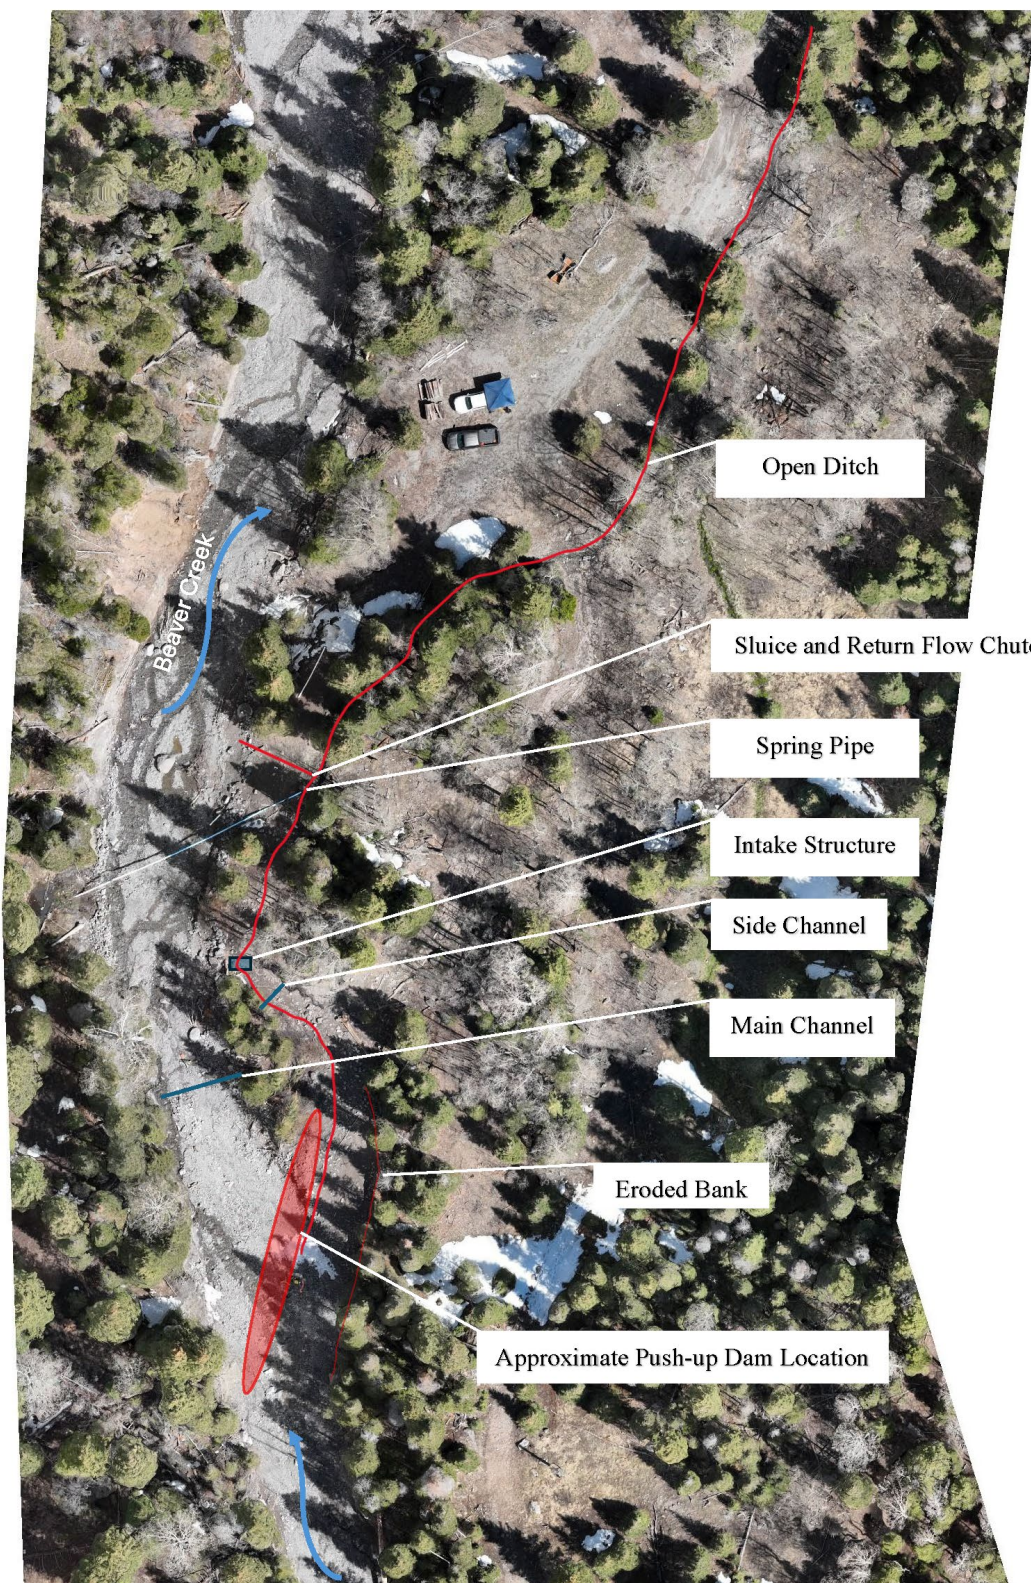
Figure 1 – Diversion Configuration

A push-up dam, constructed from in-channel materials, was installed to divert flows into the diversion structure. The push-up dam routed Beaver Creek flows from the main channel into a side channel and through an intake structure made of concrete with a steel grate. The grated intake was a Tyrolean style structure set at channel grade. The intake structure was four feet wide by eight feet long with a grate opening of ½ inch. There is a timber headwall that runs parallel to flow to separate the side channel from the diversion ditch. Behind the timber headwall a steel sluice channel functioned as a sediment trap, where there were stop logs at the end that would be used to sluice sediments back to the main channel of Beaver Creek. The sluice channel is 3 feet wide by 2 feet deep and has a capacity of about 10cfs, flows greater than 10cfs were routed back to the main channel through the chute (Figure 1 Diversion Configuration).

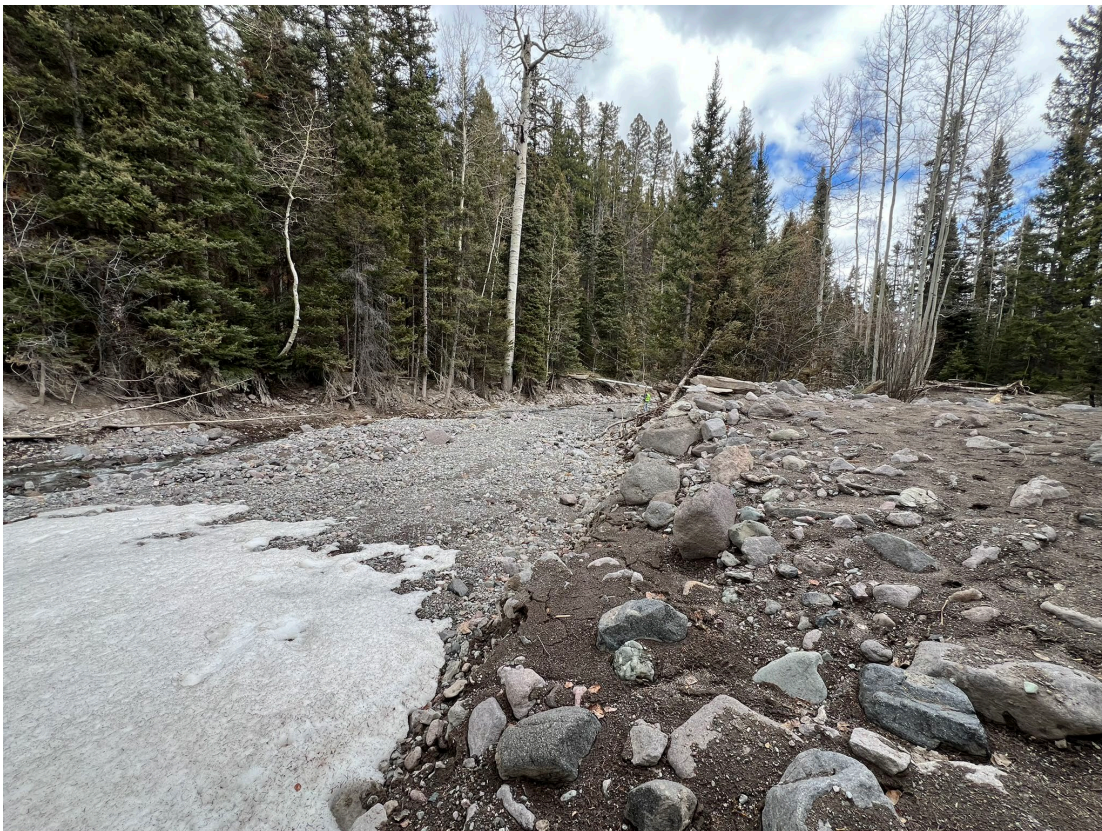
Figure 2 – Photograph looking downstream showing the main channel and side channel where the temporary avulsion occurred.

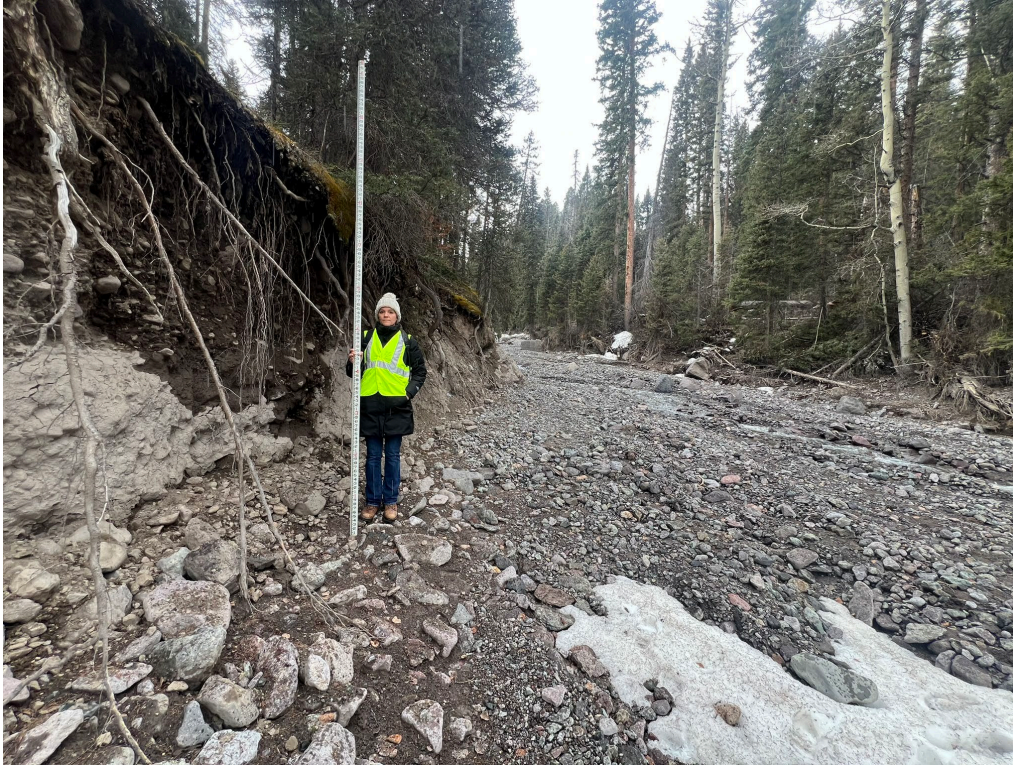
Figure 3 – Photograph looking upstream at the main channel where the channel avulsed and eroded the right bank.

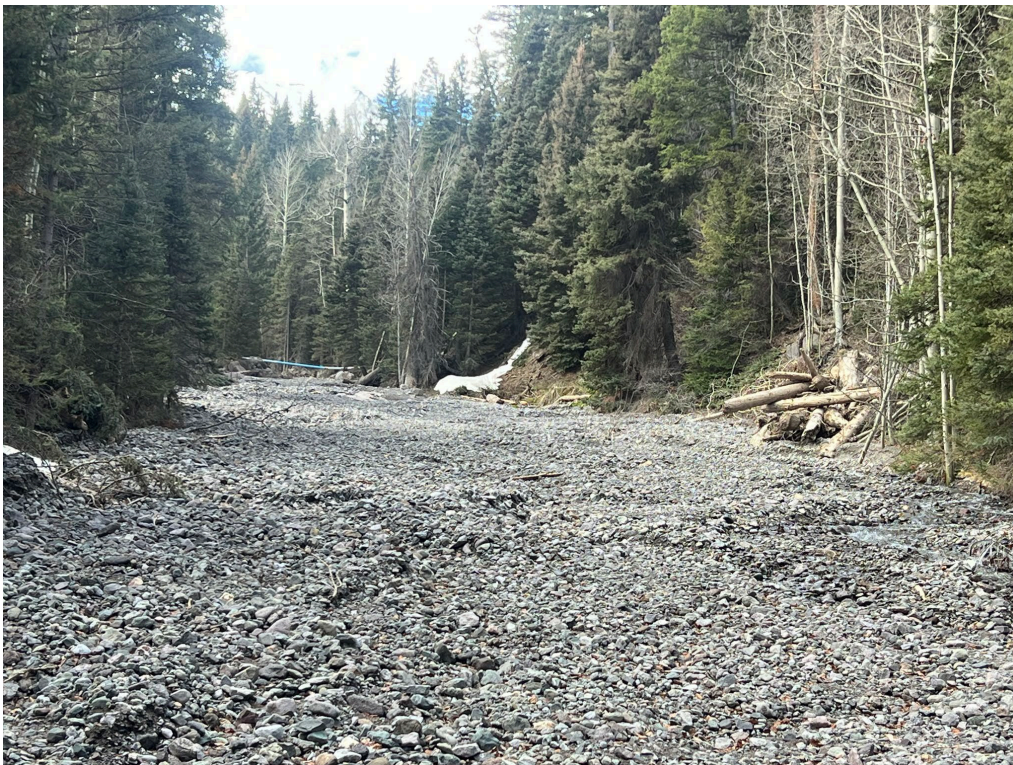
In August 2024, a high intensity thunderstorm of unknown magnitude covered the small watershed initiating a flood event. During the high-magnitude flood event, the incoming flow was heavily laden with debris, including large woody material and coarse sediments including large rocks. Debris was predominately alluvium and bulking of sediment from channel materials in the surging flood flow. The channel banks eroded and widened, providing ample materials. The push-up dam initially succeeded in routing both water and debris into the side channel. However, the increased hydraulic force and debris load initiated channel avulsion and rapidly eroded the adjacent right bank (Figure 2 and 3 Avulsion Path and Eroded Bank). This erosion was exacerbated by the high energy of the floodwaters and the unconsolidated nature of the channel and bank materials. Eventually, the push-up dam breached under the pressure of the floodwaters. Once breached, the full volume of the flood was released down the original main channel. The sudden surge transported a massive load of gravel and cobbles, which were deposited across the valley floor, effectively burying the main channel under a thick layer of coarse sediment (Figure 4 Aggradation from August 2024 Event).

Figure 4 – Photograph showing aggradation of gravels and cobbles filling the channel.

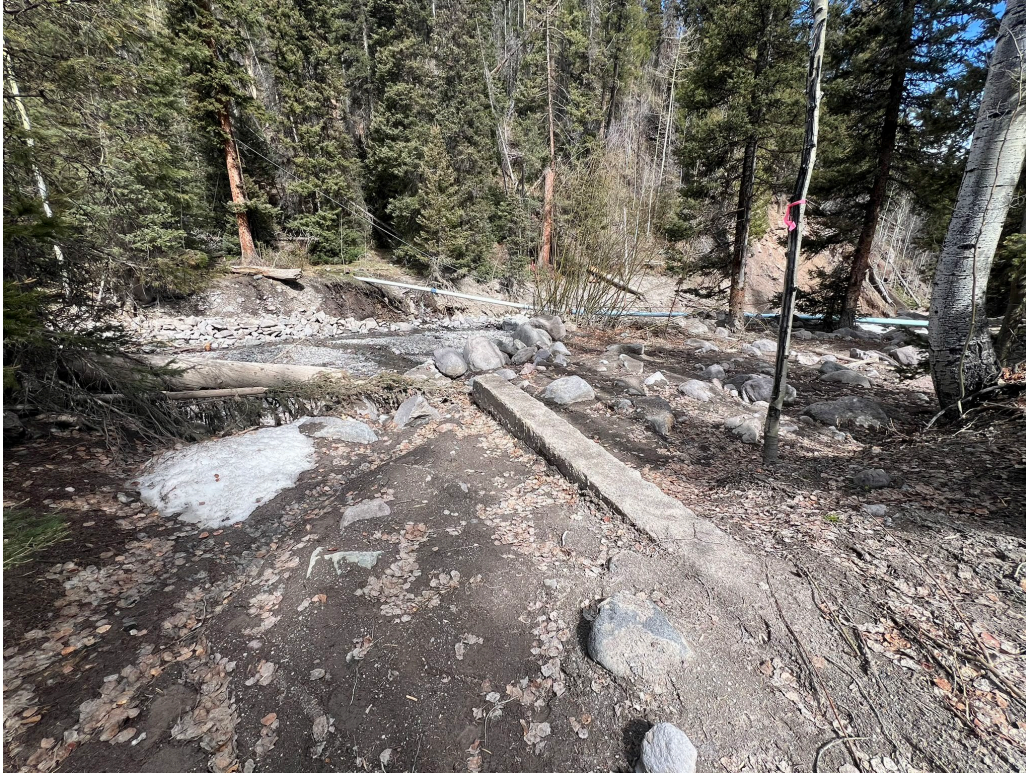
As the flood receded the diversion structure and sluice channel were completely buried with small boulders and cobbles and a veneer of fine sediments (Figure 5 and 6 Existing Diversion Structure). These fines were likely sourced from the immediate eroded bank during the avulsion process. The redistribution of sediment types across the landscape was evident during field reconnaissance, coarse materials dominating the valley floor and finer particles settling in the floodplain. Fine particles completely filled the ditch (Figure 7 Sediments Cleaned from the Ditch). The event caused the diversion and ditch to be completely inoperable to divert flows.

Figure 5 – Photograph showing the existing diversion structure filled with sediments. Only the top of the 4ft tall timber wall is exposed to the surface.

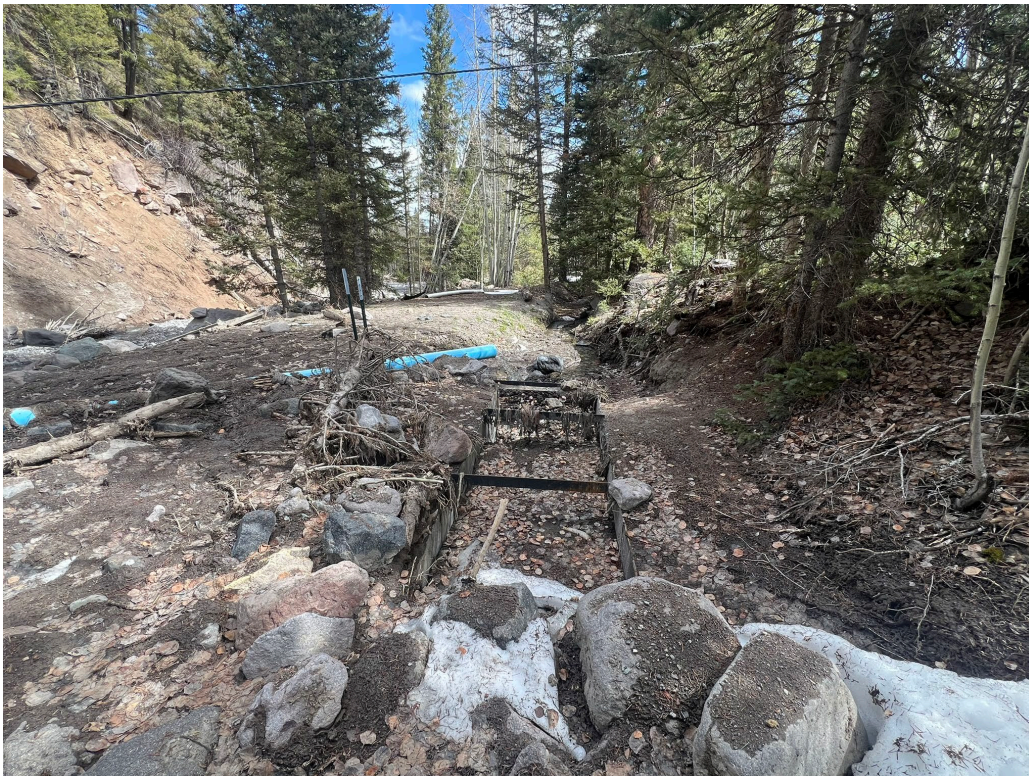
Figure 6 – Photograph showing the steel sediment channel and spring pipe. Notice the boulders that were transported and deposited at the head of the sluice channel.

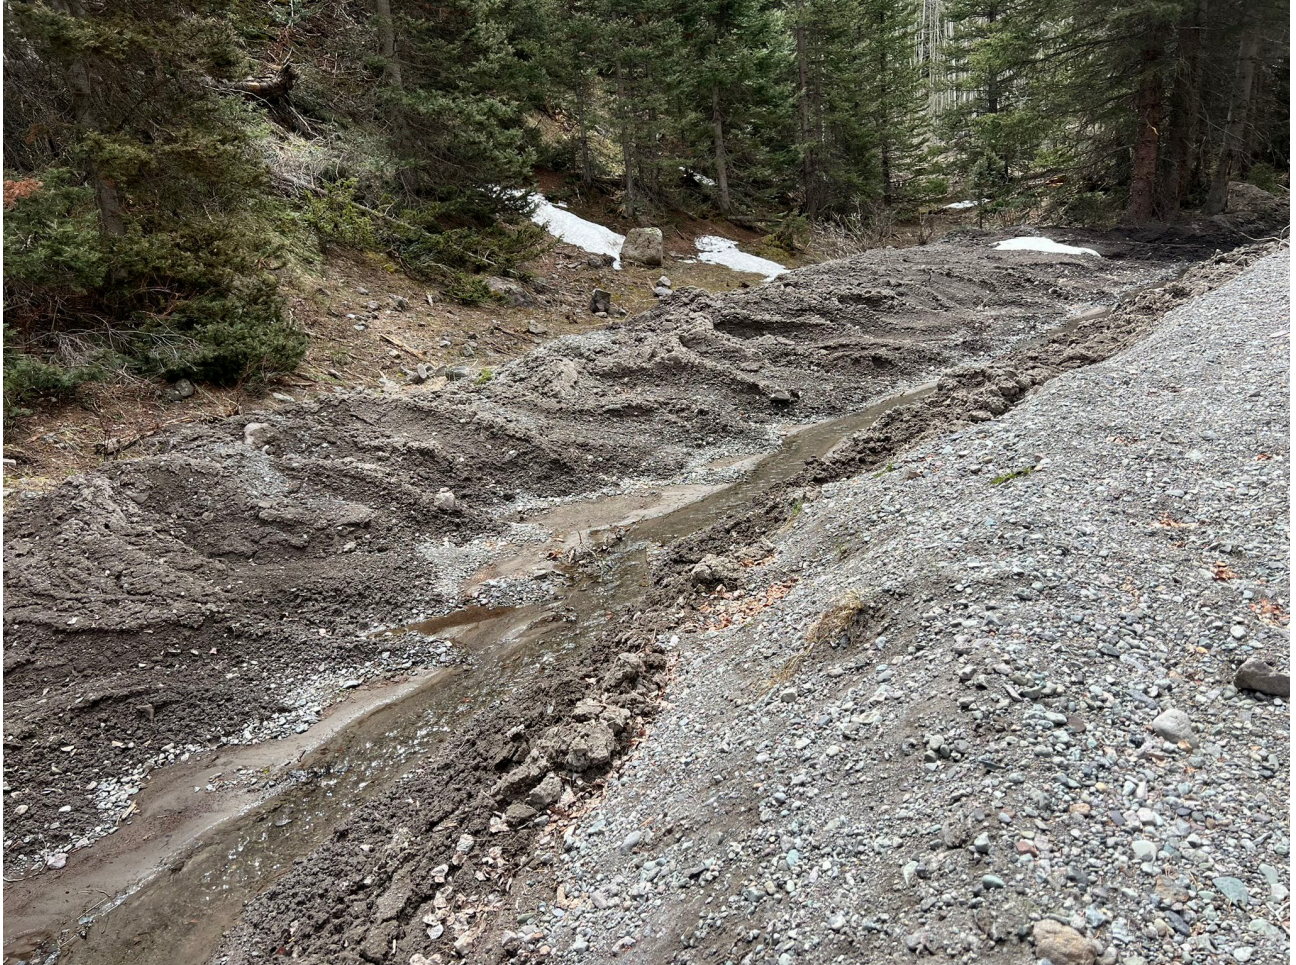
Figure 7 – Photograph showing the ditch cleaned of sand and gravel after the flood event. These materials may be reused to restore the bank as soil fill in coir wraps.

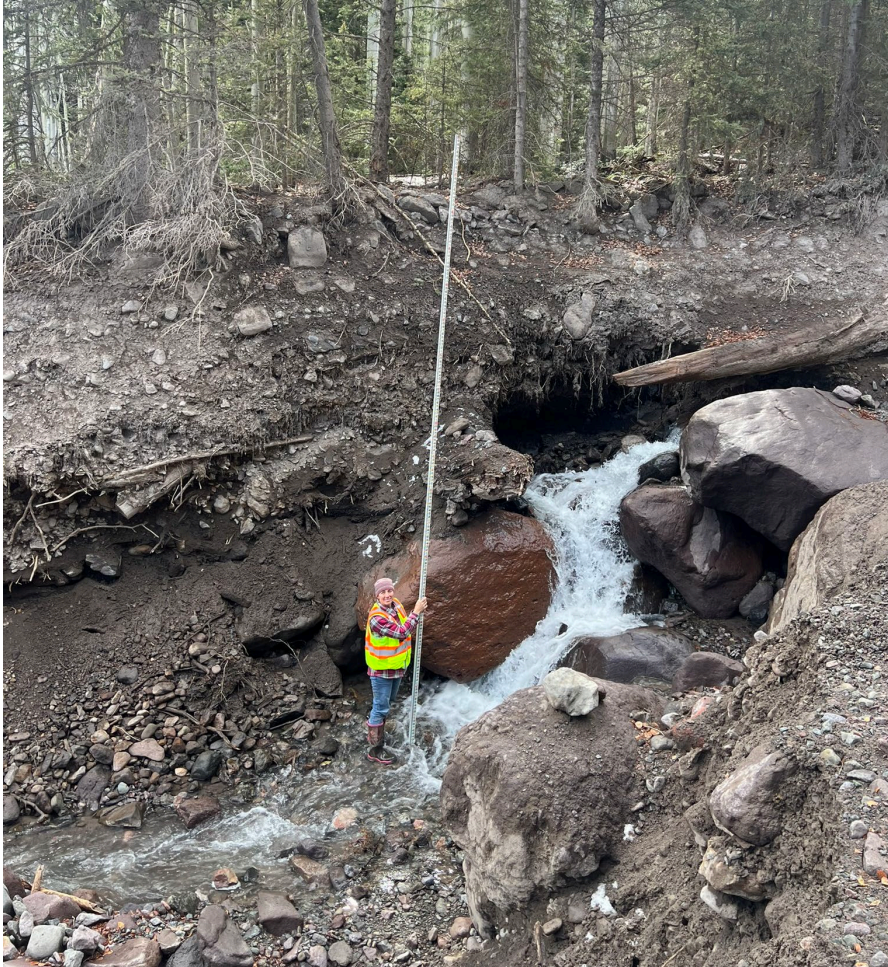
Figure 8 – Photograph showing the terminal end of glacial outwash materials.

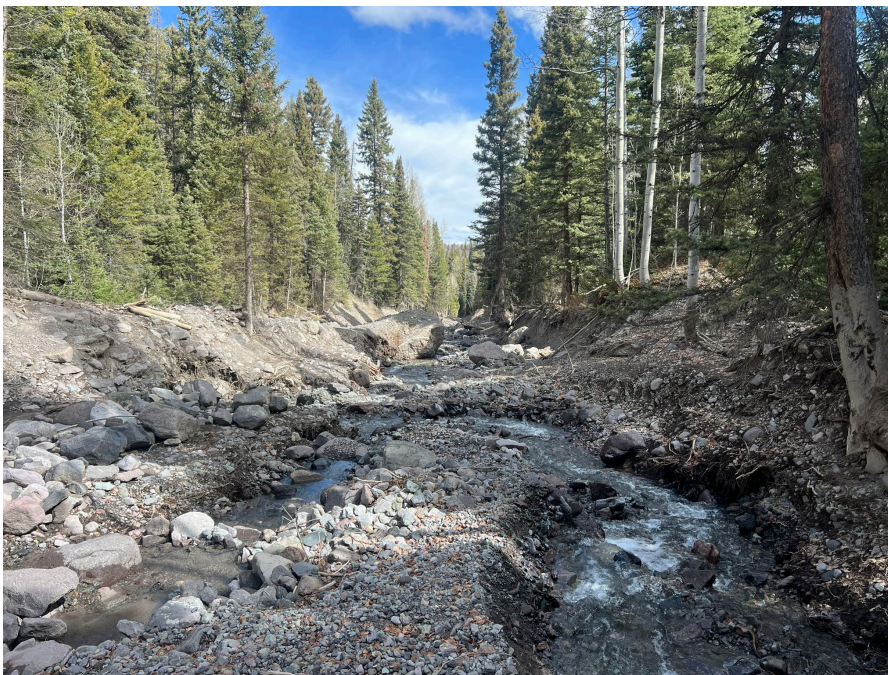
Figure 9 – Photograph showing the mid-point of the head cut approximately 1,300 feet downstream of the existing diversion location.

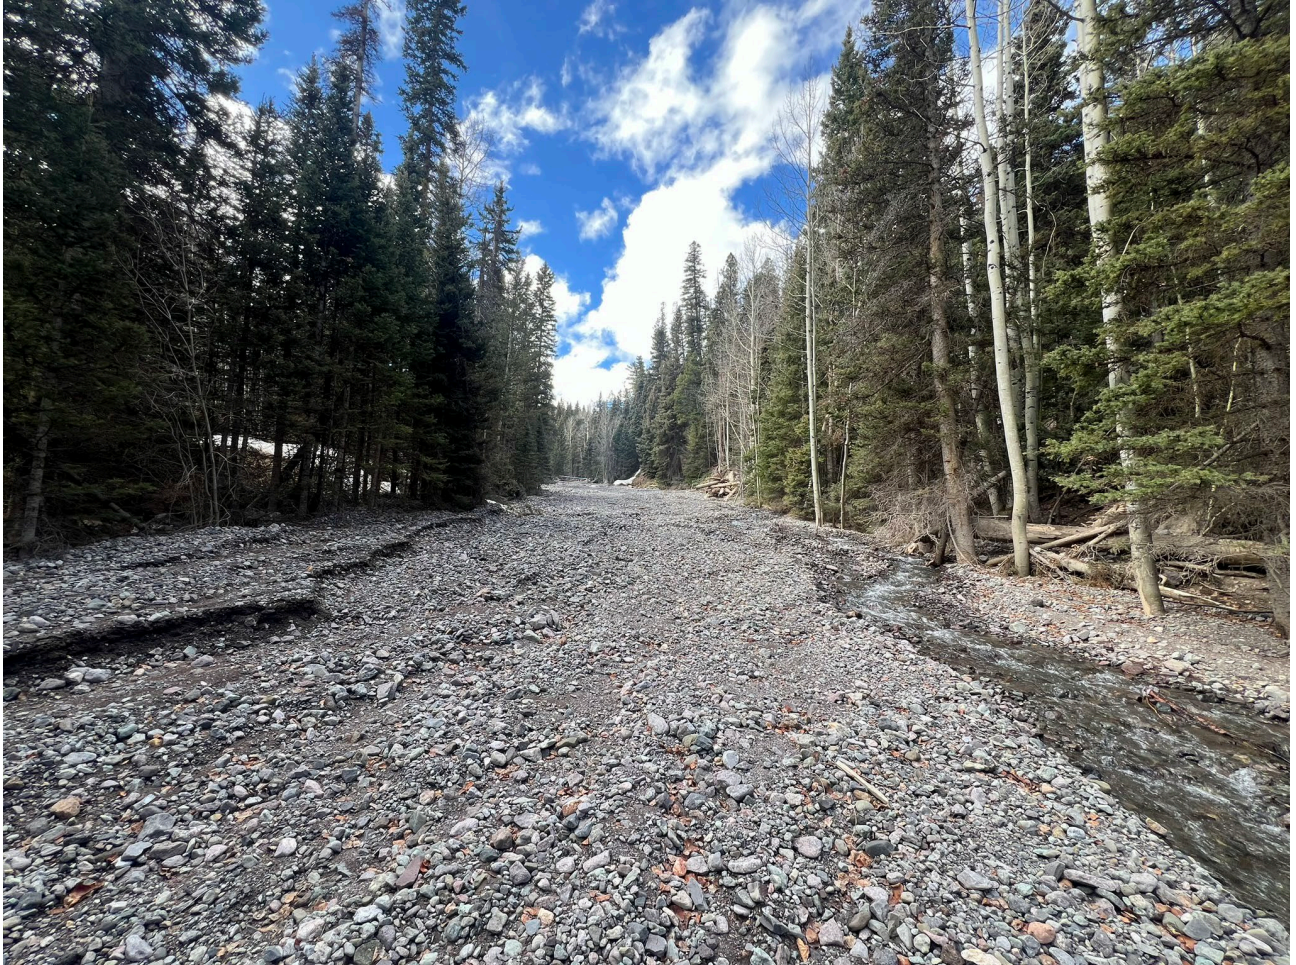
Figure 10 – Photograph showing the head cut moving up the valley approximately 700 feet downstream of the existing diversion location.

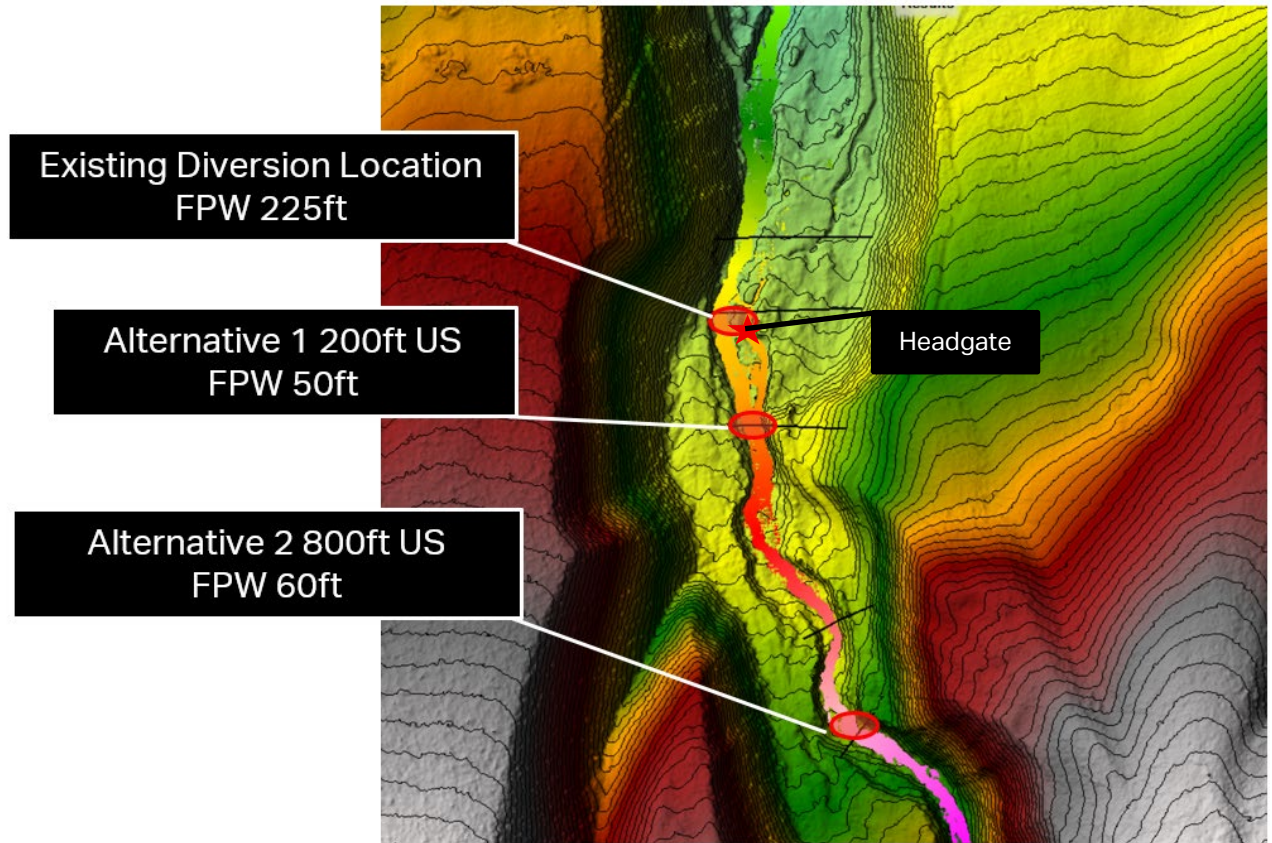
The USGS 2016 LiDAR terrain was used to evaluate the reach and determine where there are opportunities for natural confinement and stable channel locations. The geologic maps and profile did not reveal stable knickpoints that would provide natural vertical control for a diversion location. Based on the 2016 LiDAR terrain surface three locations were investigated to replace the diversion structure (Figure 11 Beaver Creek Terrain and Valley Width).

The current location of the diversion structure lies in a geomorphic transition zone where the valley widens significantly. This broader valley floor, underlain by unconsolidated landslide and glacial outwash deposits, is inherently more susceptible to overbank flows, sediment deposition, and debris spreading during high-flow events. These conditions promote the development of side channels and ephemeral high-flow pathways, increasing the likelihood of avulsion processes.

Figure 11 – Beaver Creek Terrain and Valley Width. The mounds in the topography are large glacial boulders.

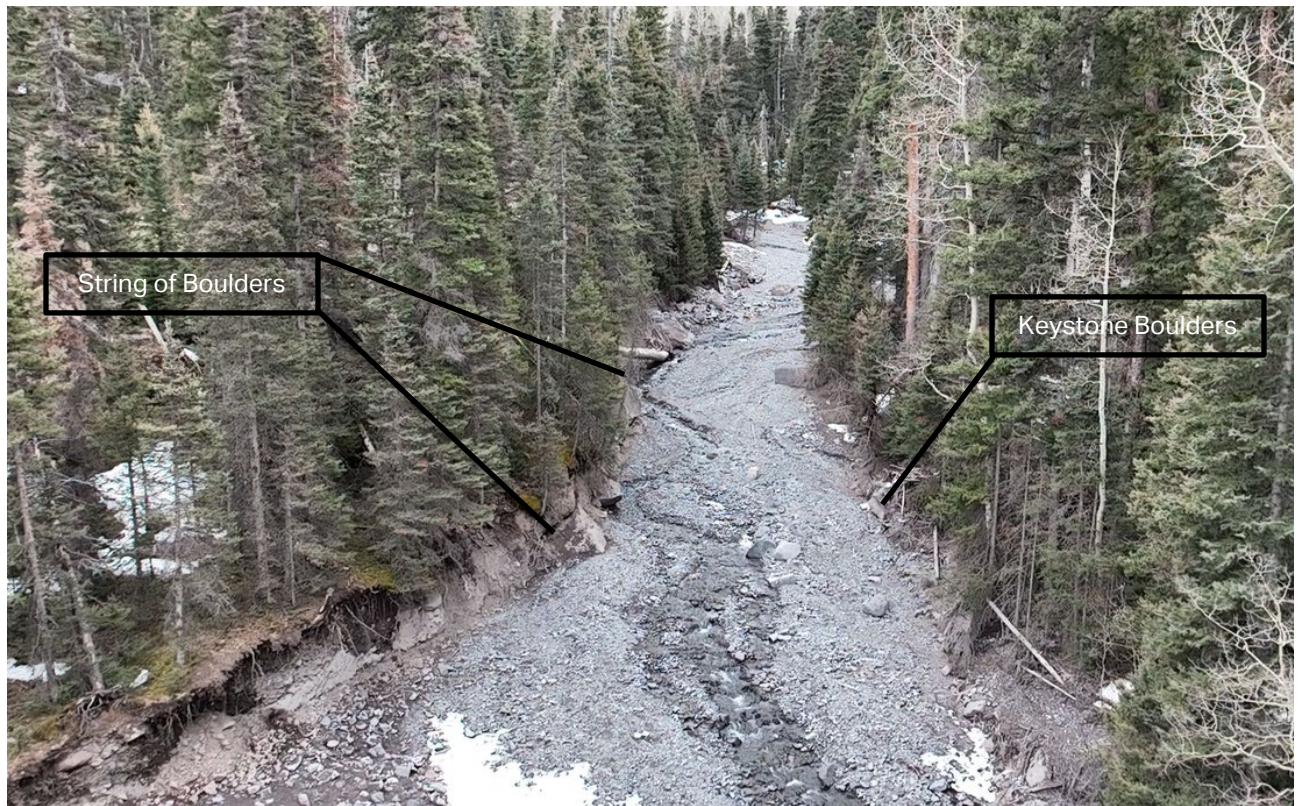
Approximately 200 feet upstream of the current diversion, a string of glacial boulders exist confining the valley to the east (right bank). The west (left) bank is confined by a floodplain terrace approximately 5 feet high above the current channel. Two large 5-6' keystone boulder are exposed, and the bank is stable with mature trees. Portions of these boulders were likely further exposed due to the down cutting of the stream during the August 2025 flood event but they prevented lateral movement of the stream. It is unlikely that future flood events would be able to disturb these boulders, but some stream training improvements may be desirable to minimize the risk of further erosion of the banks at these boulders. This location offers the most laterally stable location to construct a new diversion. A diversion structure could be keyed into both the left and right bank boulders (Figure 12 and 13 Potential Diversion Location 200ft Upstream). Per conversations with the Colorado Division 4 Water Engineer, moving the headgate to this location would not trigger a change in water rights. In addition, environmental permitting should be minimal given the close location to the existing diversion structure.

Figure 12 – Aerial view looking upstream at the potential diversion location.

The most stable location for a diversion structure is 200 feet upstream of the existing diversion location. The boulders confining the channel provide an opportunity to contain flows to the active channel. This location also has a natural meander planform that will make it easier to install flow training structures to route low-flow into the diversion structure. This location avoids a change in point of diversion requirement per the Division 4 water engineer and should have minimal environmental permitting restrictions and requirements.

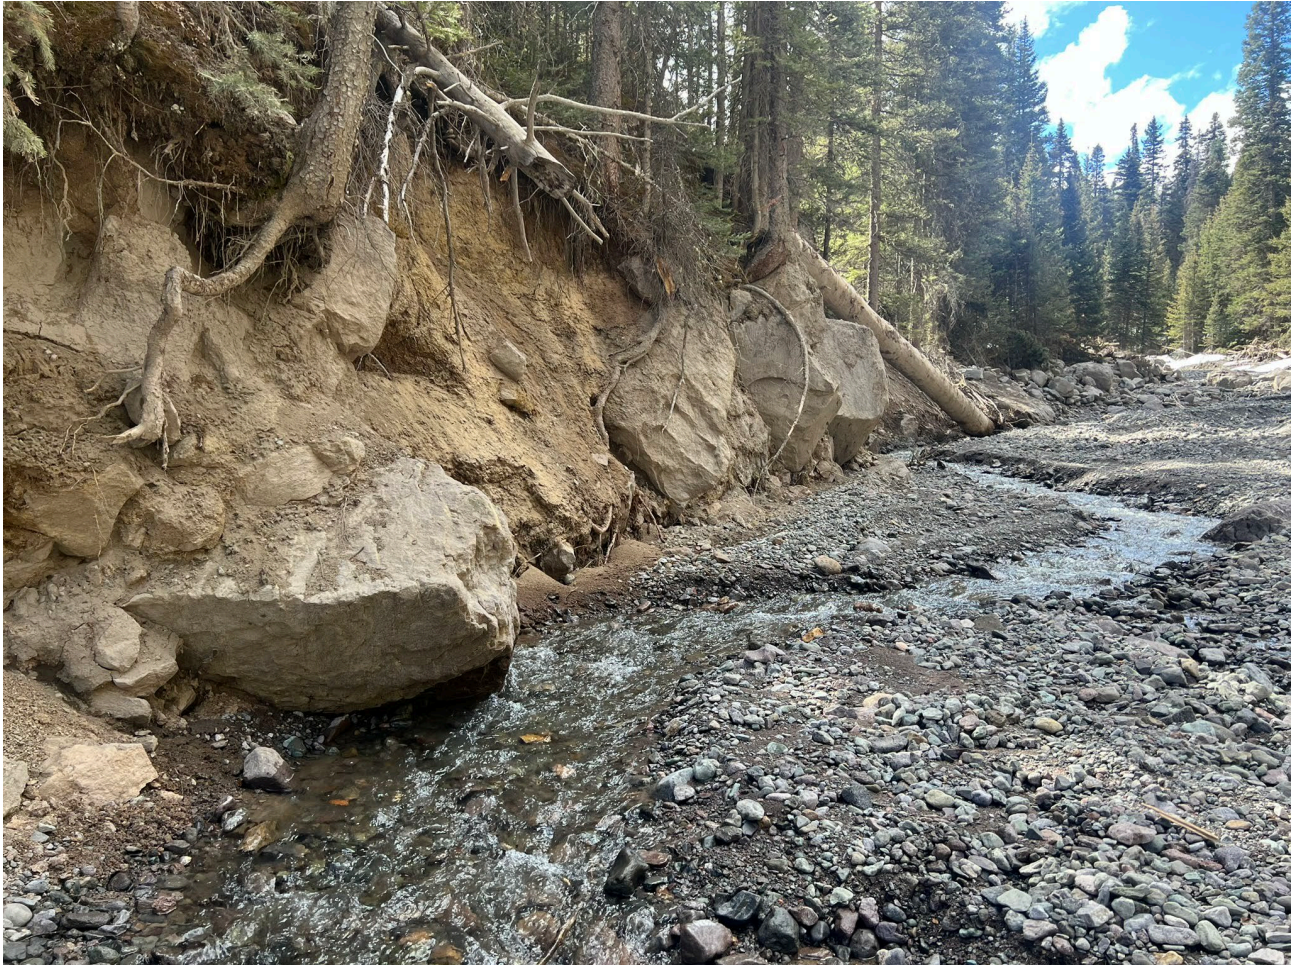
Figure 13 – Photograph is looking upstream and at the east bank showing the string of boulders confining the valley.

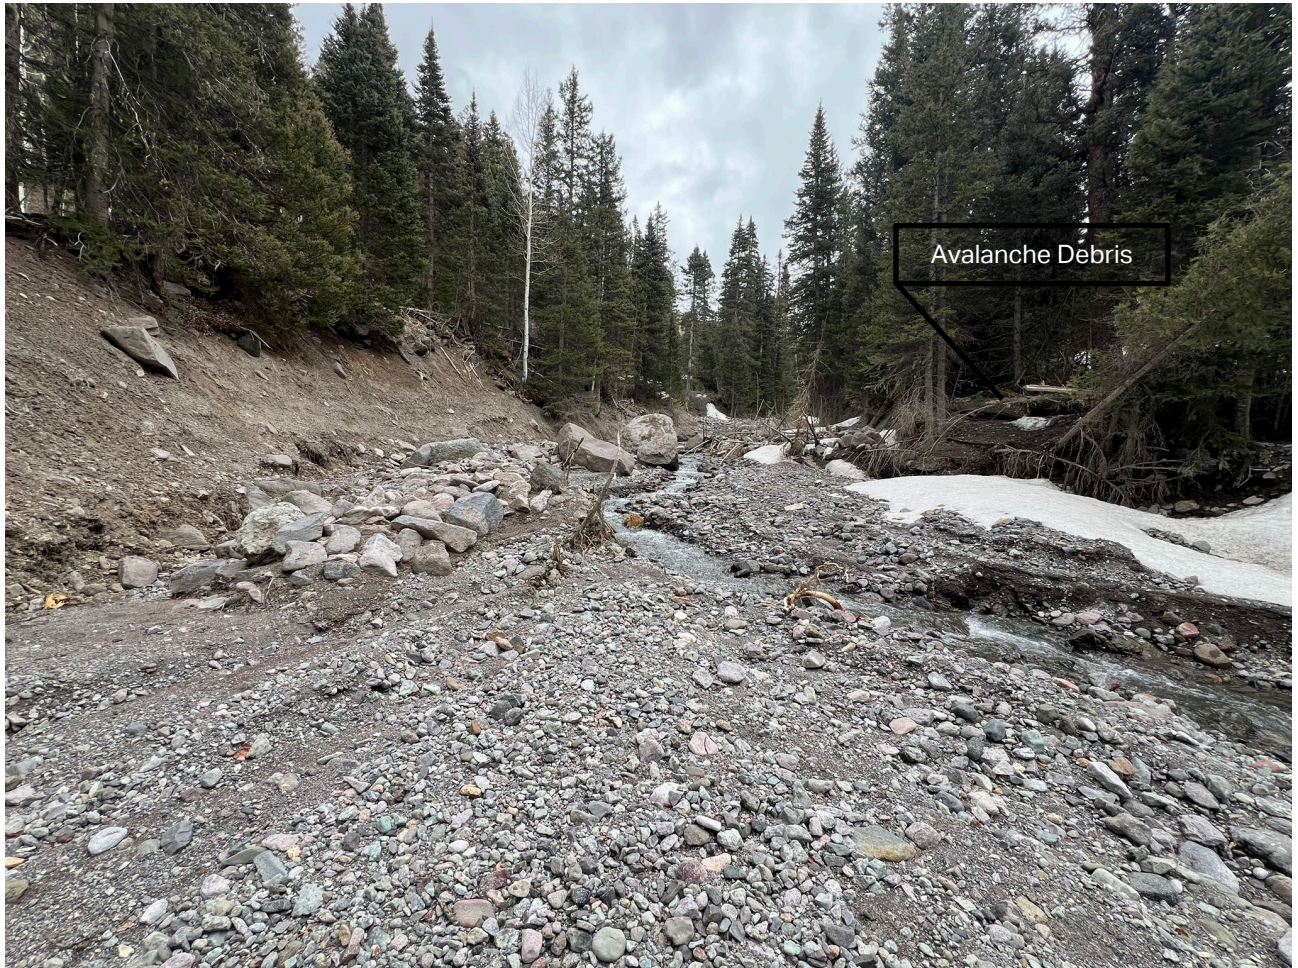
Approximately 800 feet upstream of the existing diversion structure, the Beaver Creek valley becomes significantly narrower and more confined by steep colluvial slopes (Figure 14 Upstream Location). In this reach, the channel transitions into a steeper gradient, approximately 10%, and adopts a straighter, cascade-like planform with limited low-flow meandering. While this confined section may offer greater channel stability and reduced avulsion risk, a site visit revealed several critical limitations that make it unsuitable for a diversion structure.

Most notably, the area lies directly adjacent to an active avalanche path, posing a considerable risk of sudden debris loading and channel obstruction. Additionally, the overbank area, likely a remnant of a historic diversion alignment, exhibits exposed groundwater and wetland features. Installing a diversion pipe through this zone

Figure 14 – Photograph looking upstream at the channel approximately 800 feet upstream of the existing diversion location.

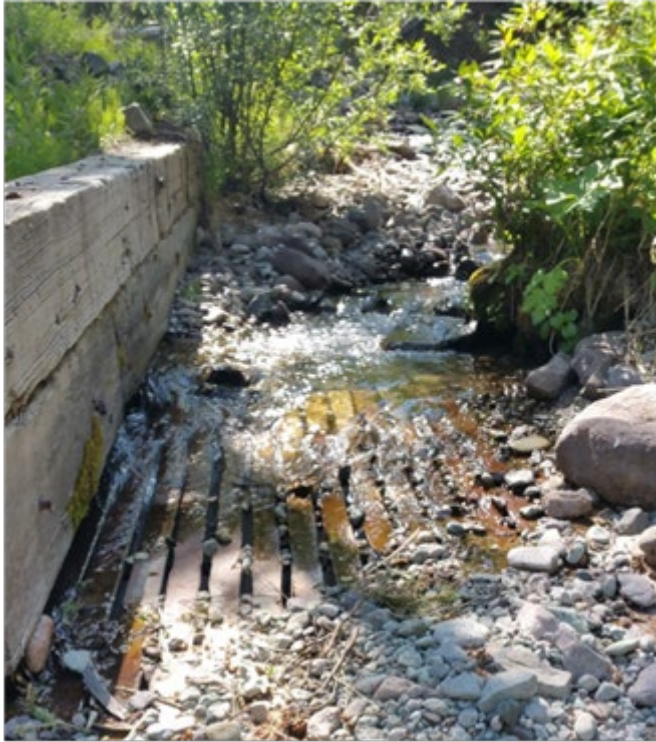
Figure 15 – Photograph of the existing intake grate structure .

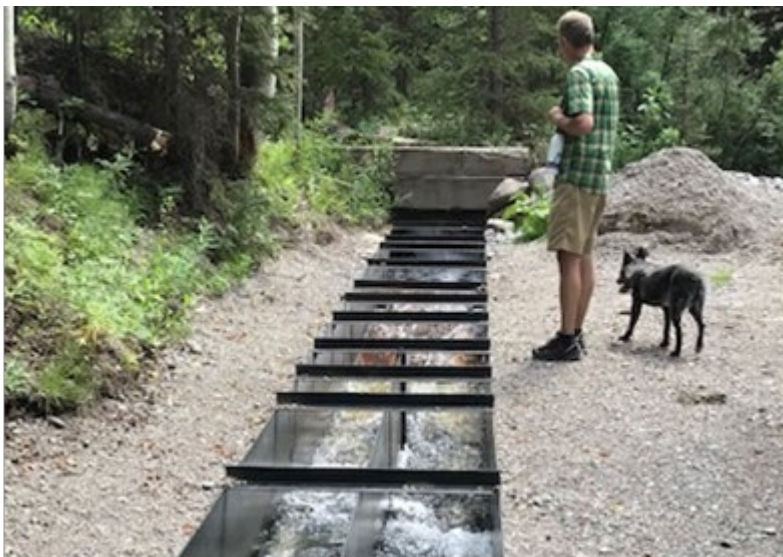
Figure 16 – Photograph of the existing sluice channel with adjustable vane.

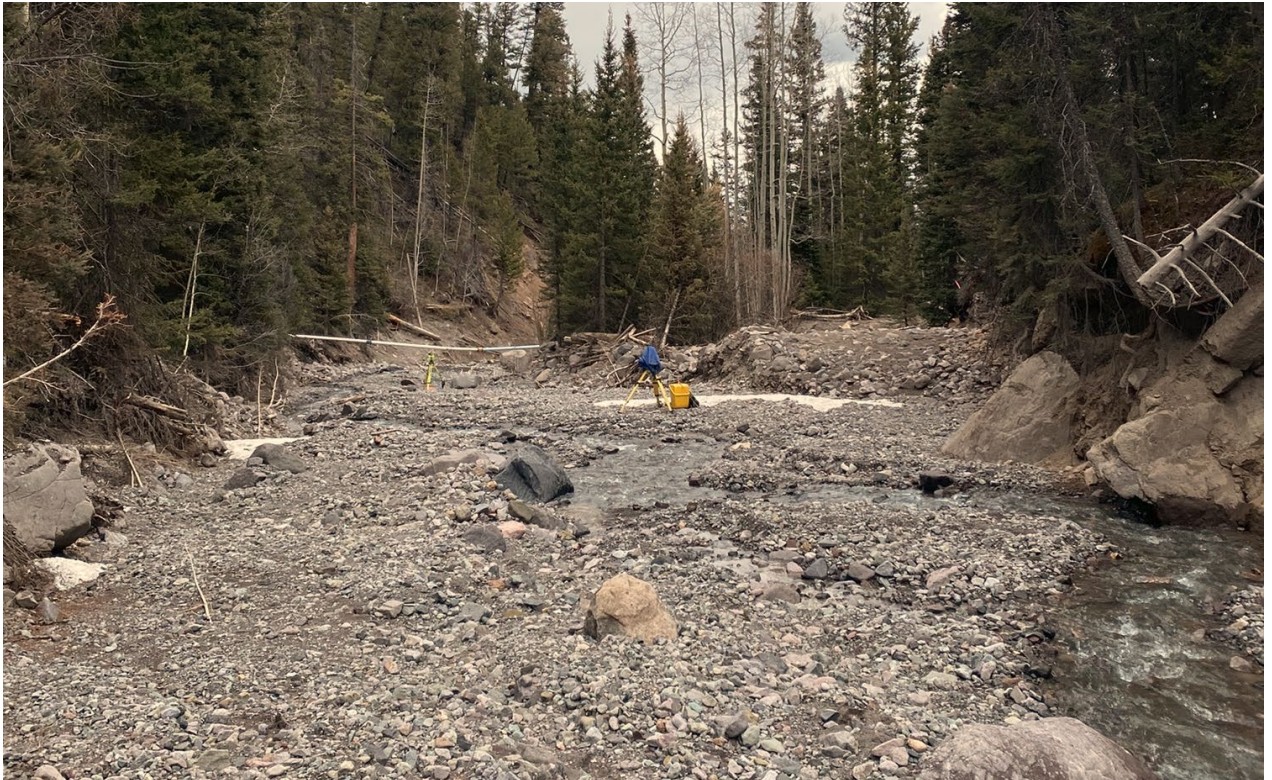
The approximate height of the push-up dam is unknown which makes it difficult to understand the actual magnitude of flows which were routed to the side channel. However, it is our understanding that all flows up to the bankfull flow was routed to the diversion structure. The push up dam constructed of channel materials failed during the flood and debris event, eventually breaching where flows went back into the main channel. The east bank substantially eroded creating a much larger side channel. Overall, the damage that took place in the channel requires significant and costly repairs to restabilize this diversion location to allow it to operate in a comparable manner as it did historically. Additionally, the existing channel side channel was filled with two to four feet of sediment which therefore must be excavated to again deliver channel flows to the intake grate structure location.

Figure 17 – Photograph is facing downstream toward the existing diversion channel on the right, showing the significant fill that must be cut to restore the channel.
