# Ridgway Community Forest Management Plan

Ridgway Parks, Trails, and Open  
Space Committee  
Colorado State Forest Service,  
Montrose District

May 2016

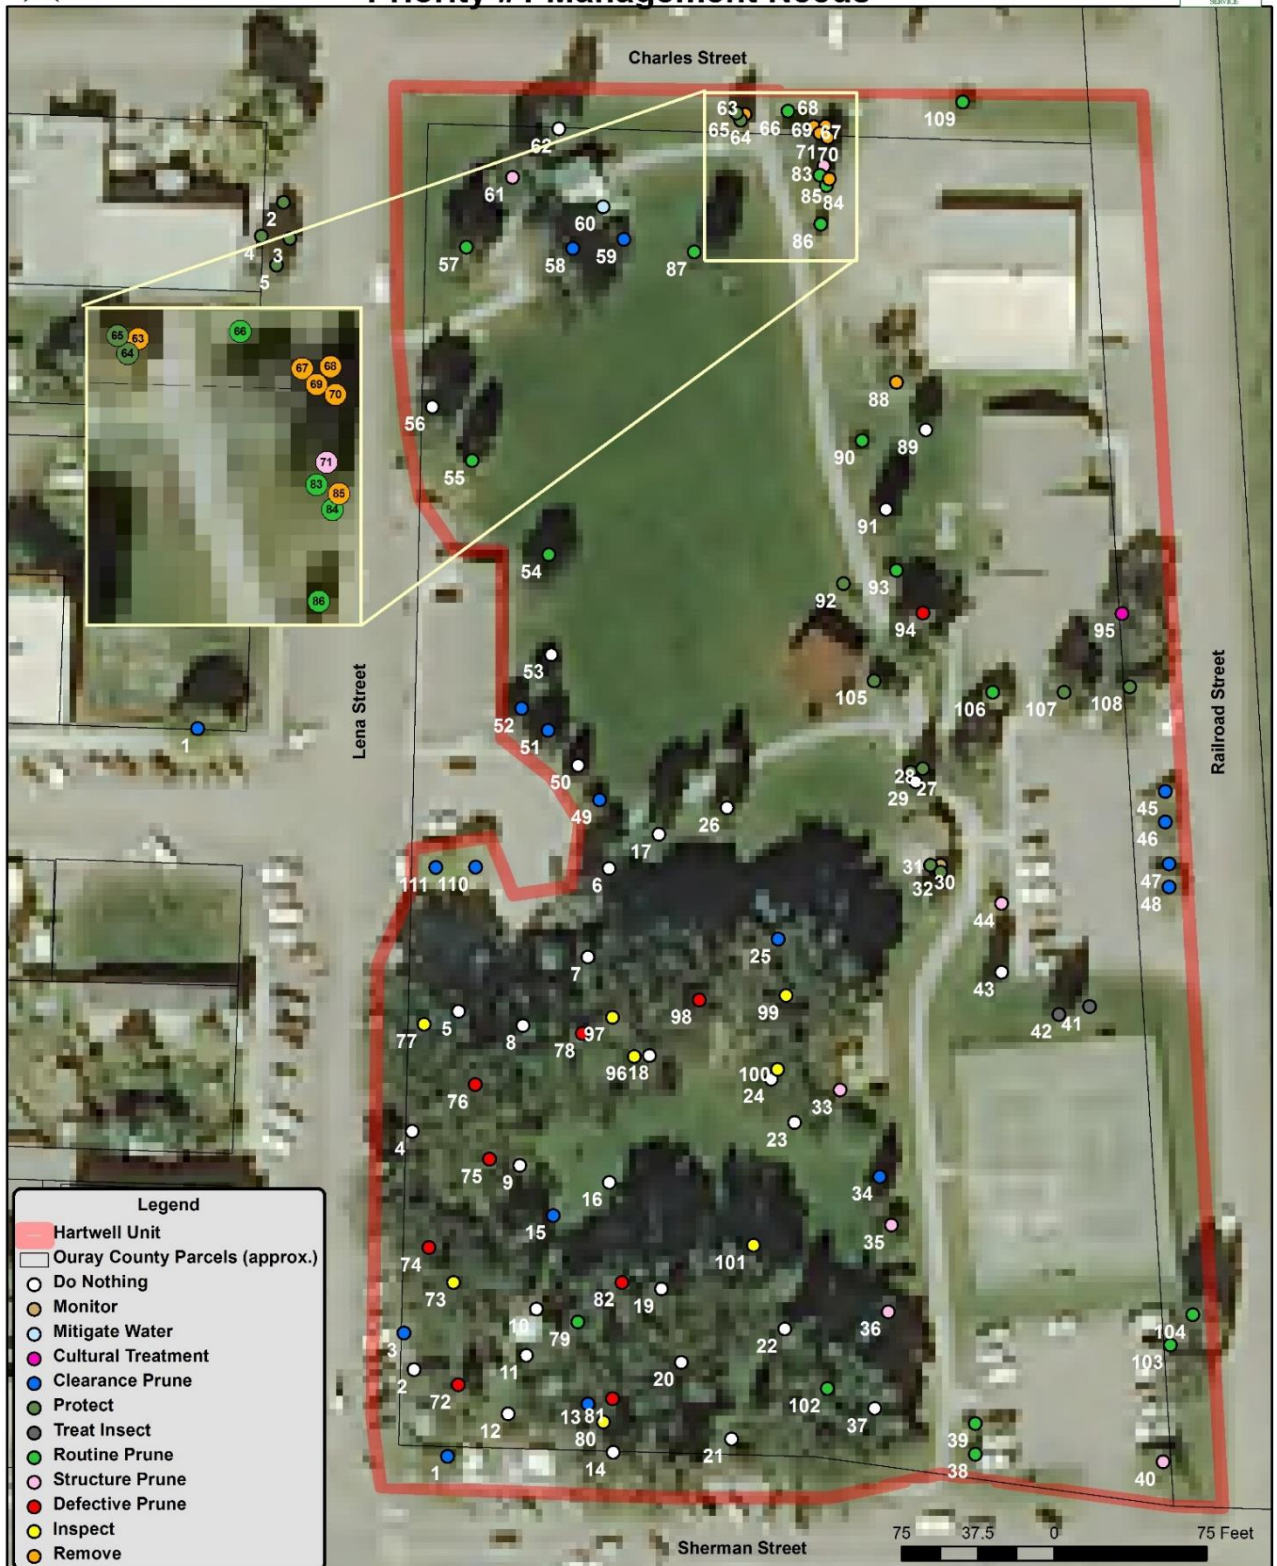
## Hartwell Park Unit Priority #1 Management Needs

| Hartwell Unit - Prioritized Tree Management Needs for Risk Rated Trees | | | | | | | | | | | |
|---|---|---|---|---|---|---|---|---|---|---|---|
| Hartwell Park | 101 | Rio Grande Cottonwood | 39.0-40.9 | Inspect | percent decay | Structure Prune | conflicting branches | | | 12 | |
| Hartwell Park | 81 | Rio Grande Cottonwood | 37.0-38.9 | Defective Prune | | Inspect | basal decay | | | 13 | |
| Hartwell Park | 76 | Narrowleaf Cottonwood | 39.0-40.9 | Defective Prune | dead wood | | | | | 15 | evaluate basal decay - see mushrooms |
| Hartwell Park | 78 | Rio Grande Cottonwood | 35.0-36.9 | Defective Prune | conflicting branches and dead wood | | | | | 15 | |
| Hartwell Park | 72 | Narrowleaf Cottonwood | 33.0-34.9 | Defective Prune | dead wood | Monitor | | | | 16 | |
| Hartwell Park | 73 | Rio Grande Cottonwood | 65.0-66.9 | Inspect | decay extent | Defective Prune | | | | 16 | cabled; decay in trunk |
| Hartwell Park | 96 | Rio Grande Cottonwood | 39.0-40.9 | Inspect | percent decay | Routine Prune | | | | 16 | |
| Hartwell Park | 100 | Rio Grande Cottonwood | 45.0-46.9 | Inspect | percent decay | Structure Prune | conflicting branches | | | 16 | inspect |
| Hartwell Park | 74 | Rio Grande Cottonwood | 49.0-50.9 | Defective Prune | | | | | | 17 | prune out problem - included bark over parking |
| Hartwell Park | 94 | Cottonwood | 23.0-24.9 | Defective Prune | prune broken top to top of N limb | | | | | 17 | prune |
| Hartwell Park | 77 | Rio Grande Cottonwood | 57.0-58.9 | Inspect | decay | Inspect | cabling | | | 17 | co-dominants with bark inclusion |
| Hartwell Park | 98 | Rio Grande Cottonwood | 49.0-50.9 | Defective Prune | dead wood | Inspect | percent decay | | | 18 | |
| Hartwell Park | 82 | Rio Grande Cottonwood | 59.0-60.9 | Defective Prune | problem branches | Other | decay | | | 18 | move tables |
| Hartwell Park | 75 | Narrowleaf Cottonwood | 33.0-34.9 | Defective Prune | dead wood or move table | | | | | 18 | move picnic table |
| Hartwell Park | 97 | Rio Grande Cottonwood | 37.0-38.9 | Inspect | percent decay | Structure Prune | conflicting branches | | | 18 | evaluate status of cables and decay |
| Hartwell Park | 80 | Narrowleaf Cottonwood | 35.0-36.9 | Inspect | basal decay | | | | | 18 | mushrooms at base |
| Hartwell Park | 99 | Rio Grande Cottonwood | 49.0-50.9 | Inspect | percent decay | Defective Prune | conflicting branches | | | 19 | inspect and prune |

Management needs of risk-rated trees within this unit vary, but there are no cottonwood removals necessary at this time. However, eight trees were identified as needing more thorough inspections. Those trees that have "inspection" noted as their primary management need, should have sonic tomograms done to determine quantity and distribution of internal decay. These tests should be backed up with resistance recording drill tests for trees with 75% or more internal decay detected by the tomogram. These tests will need to be done by an ISA certified arborist with the proper tools and training to do so. See Appendix K for more information on sonic tomography and how resistance recording drills work. A current list of contractors that may be able to help with this can be attained by calling the Colorado State Forest Service. In general, be proactive in large cottonwood removals. Don't wait for risky trees to fall. The park is used too much to take a chance on someone getting hurt. In fact, it would be prudent to have an ISA Certified Arborist on retainer to inspect the largest cottonwoods at least once a year and focus on trees with either whole tree or branch failure potential around the playground, any trees with branches over hanging existing parking on N. Lena Street and Highway 62 and all other large cottonwoods in Harwell; in that order of priority.

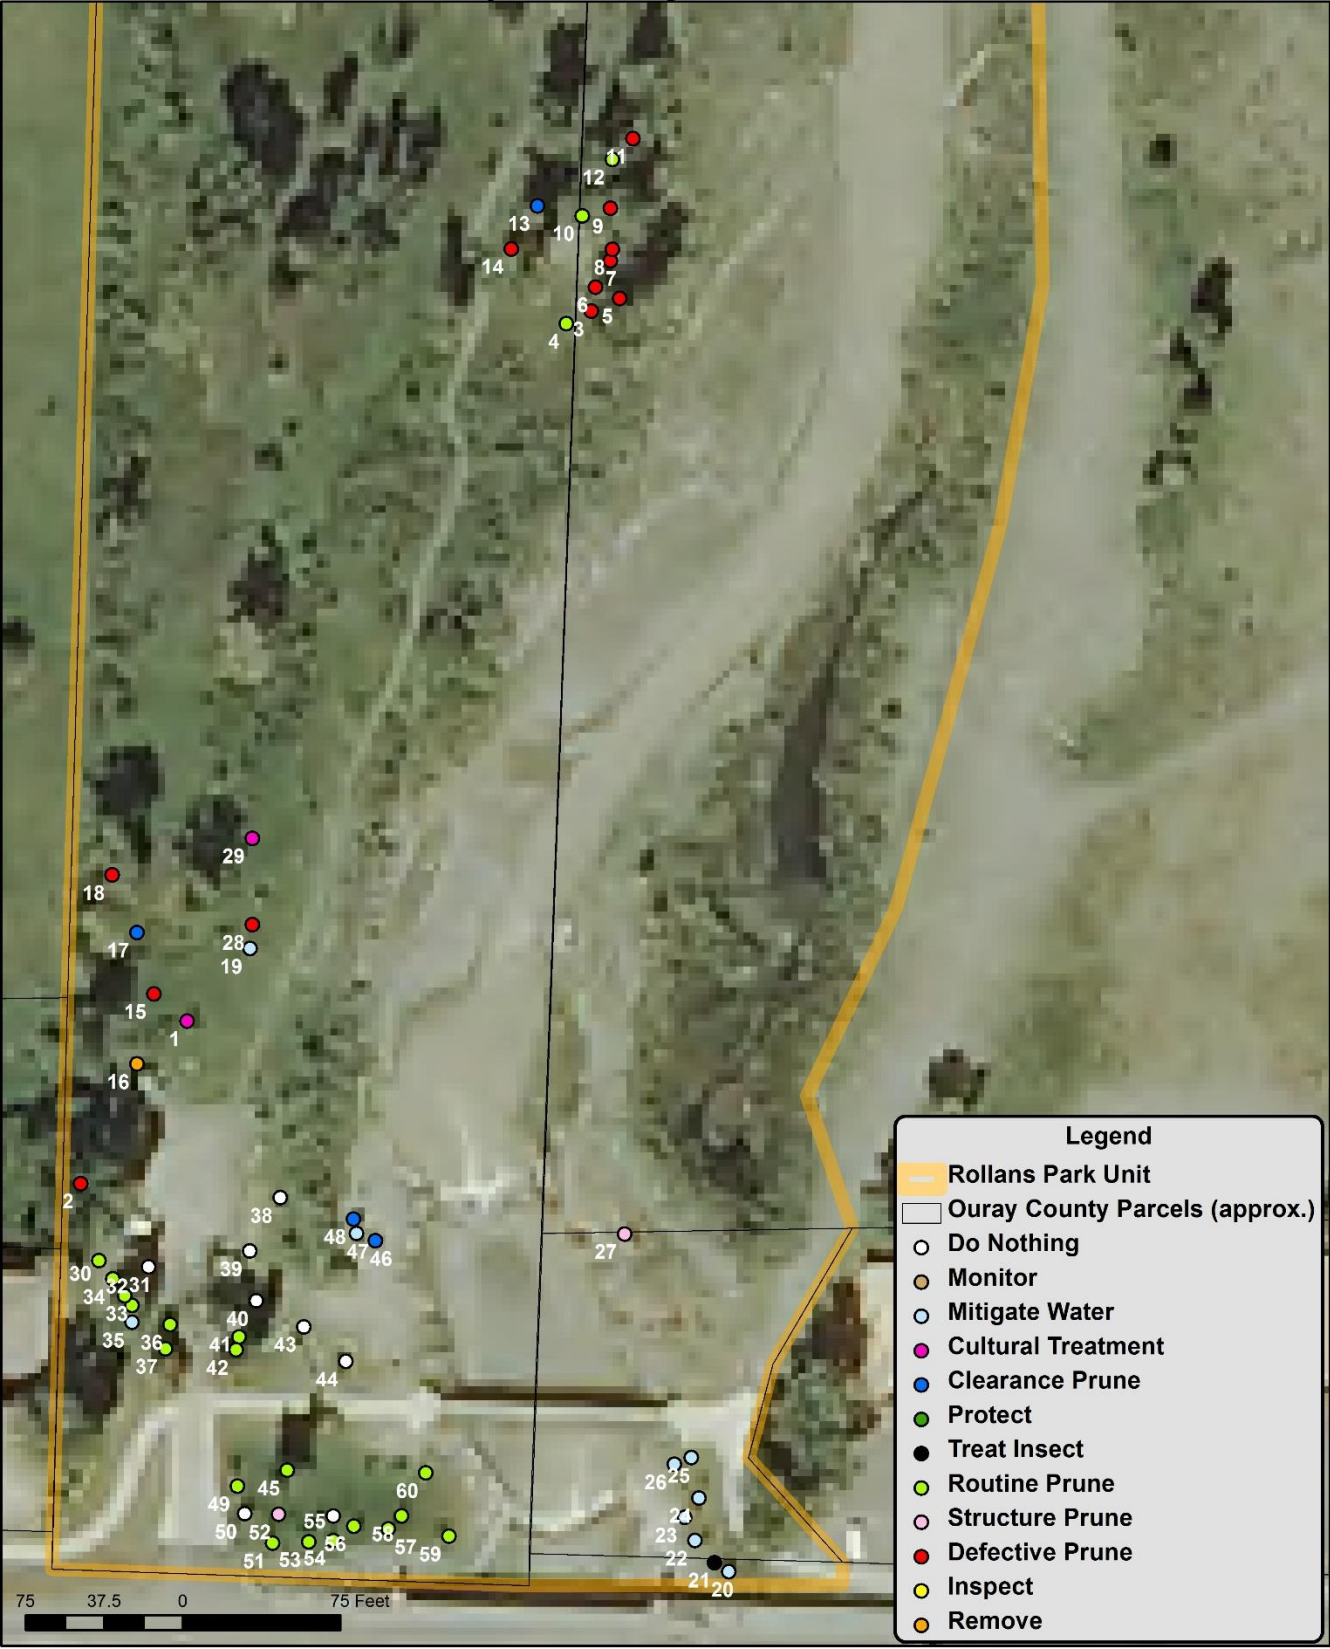
# Rollans Park Unit Priority #1 Management Needs

The Narrowleaf Cottonwoods in the area of the GOCO funded amphitheater are in need of several defective prunings due to dead tree tops that could fall on people sitting in the amphitheater. Tree ID #11 should be turned into a wildlife tree and has a very high risk rating of 20. Tree ID #6 is dead and should also be turned into a wildlife tree. See Appendix H for specifications on creating wildlife trees.
