# CAPITAL ASSESSMENT REPORT

## TOWN OF RIDGWAY

Final Report  
Staff Updates  
March 12, 2019

Adopted by Town Council  
April 10, 2019

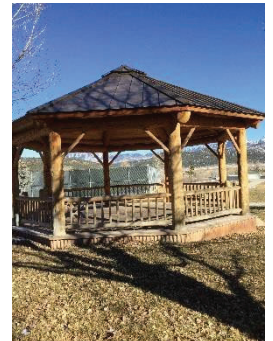
The Gazebo in Athletic Park was constructed in 2000. It is an octagonal open building of ~300 square feet. It is located in the Athletic Park by the tennis courts and skate park.

Structural Integrity: The gazebo is a log frame structure with a metal panel roof. Lumber roof decking is supported by log beams, columns, and knee braces. The floor is constructed of lumber decking supported by dimensional lumber floor joists. The foundation consists of cast in place concrete piers. The bottom end of the log columns that are exposed to the weather show signs of likely degradation. Overall condition is good.

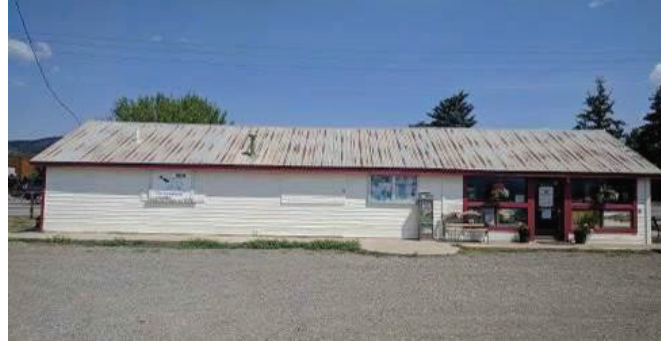
The Visitor Center was constructed in 1945. It is ~1,212 square feet in size. It houses the Chamber of Commerce Visitors Center and the Railroad Museum.

**Structural Integrity:** The Fairgrounds Visitors Center is a wood frame building on a concrete slab on grade floor. While most of the structure was not visible, some sag of the roof was observed which may indicate some deflection or possible degradation of the roof framing. Overall, the condition of the building was fair.

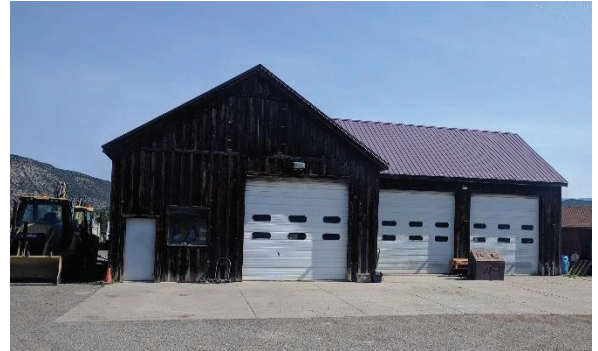
The Public Works facility was constructed in 1996. It is ~2,928 square feet in size and houses the Shop. Directly to the east is the Public Works Office, which is covered in the next section.

Structural Integrity: The public works shop building is a wood frame building on what appears to be a concrete foundation and a concrete slab on grade floor. Manufactured wood roof trusses make up the roof structure. Walls appear to consist of 2X6 bearing wall framing with external wall girts and rustic wood siding. While the majority of the structural elements were not visible, the structure appeared to be in good condition.

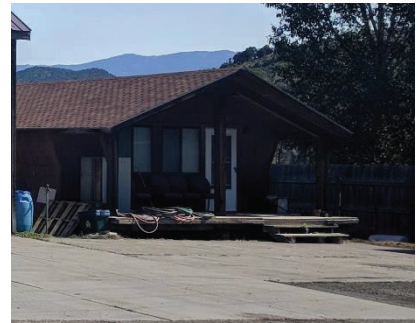
The Public Works Hut was constructed in 1996 and is ~571 square feet in size and has 2 office desks for daytime work, generally occupied by the Town Engineer on an as-needed basis and the Public Works crew.

Structural Integrity: The Public Works Hut is a wood frame building on concrete masonry block pier foundations. The CMU block piers appeared to be a similar construction to temporary trailer or modular office installation standards. While the majority of the structure was not visible, the structure appeared to be in good condition with no significant signs of failure.

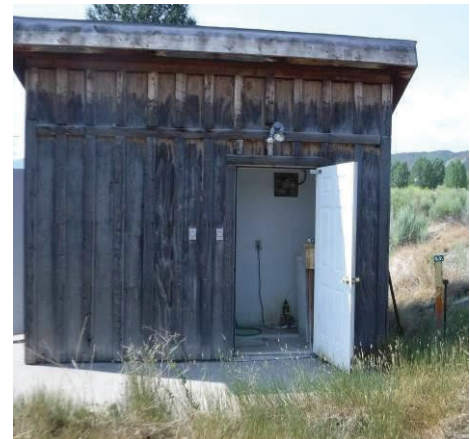
Structural Integrity: The treatment building is a wood frame building on a concrete slab floor. While many structural elements were not visible, the structure appeared to be in good condition with no significant signs of failure.

- Description: The building is heated via one electric baseboard heater and ventilated via one exhaust fan (both wall mounted). The condition is described as fair to poor given the corrosion caused by chlorine (which is to be expected).
- Discussion: Overall the system was understood to be functioning as designed and is consistent with the building type and usage. Recommendations are to periodically monitor the corroded baseboard heater and exhaust fan and replace upon failure.

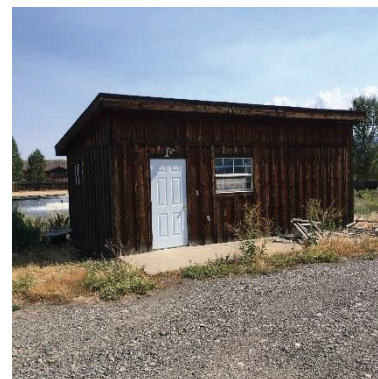
Another building at the WWTP is a control building, which houses the adjacent aerated lagoon treatment system electrical and controls equipment and a laboratory. The Lab/Control building was completed in 2000 and is ~288 square feet in size.

Structural Integrity: The treatment plant is a wood frame building on a concrete slab floor. While many structural elements were not visible, the structure appeared to be in good condition with no significant signs of failure.

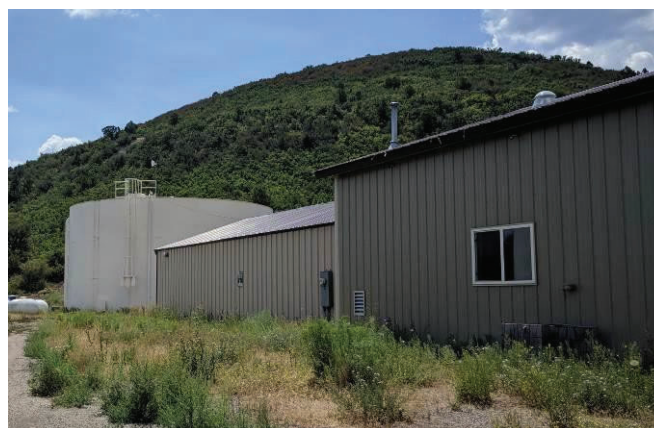
The WTP consists of one ~1,500 square-foot building that was originally constructed in 1980 to house the filtration treatment process equipment, chemical storage and an office/laboratory. The building was expanded in 2006 with a 1,080 square-foot addition to the north for the purposes of housing two new skid-mounted membrane filter systems, electrical and controls equipment and chemical storage. Two 300,000 - gallon steel storage tanks are located adjacent to the water plant.

Structural Integrity: The original water treatment plant building is a manufactured steel building with steel roof purlins and wall girts supported on a structural steel frame. The foundation appeared to be cast in place concrete piers with a concrete slab on grade floor. The column bases showed some signs of minor corrosion. The addition to the water treatment plant appeared to be a wood frame structure on a concrete foundation with a slab
