# CAPITAL ASSESSMENT REPORT: Water Treatment and Distribution System

## TOWN OF RIDGWAY

Final Report  
April 30, 2019

**Prepared by:**  
Consolidated Consulting Services  
PO Box 1073  
Ridgway, CO 84132

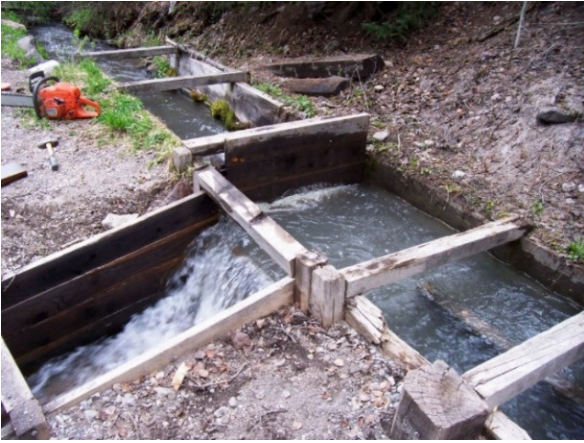
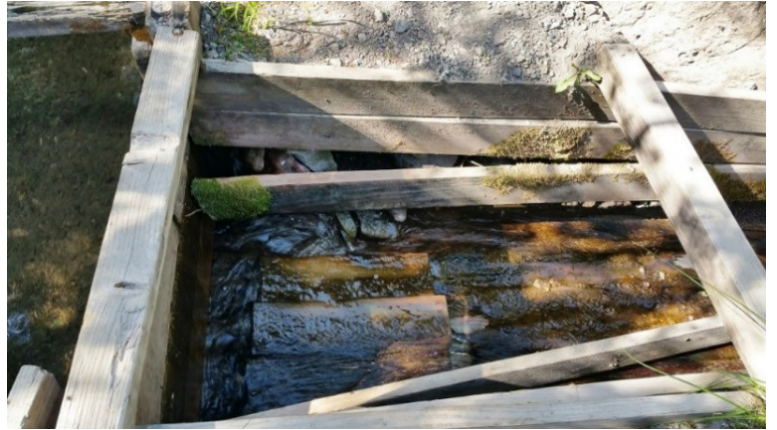
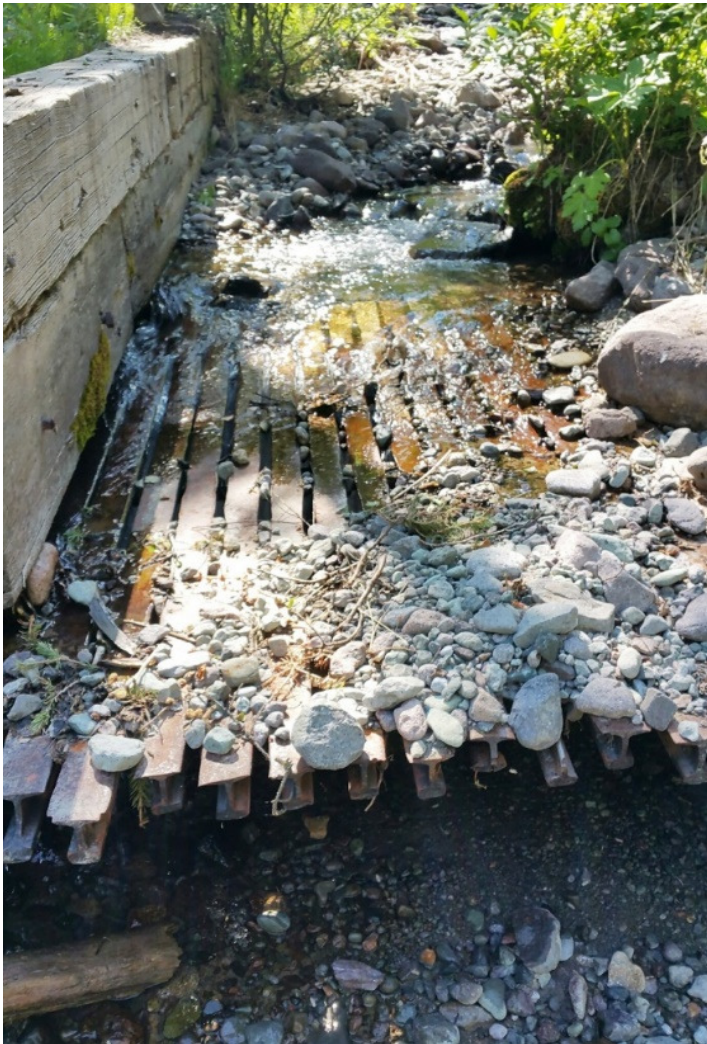
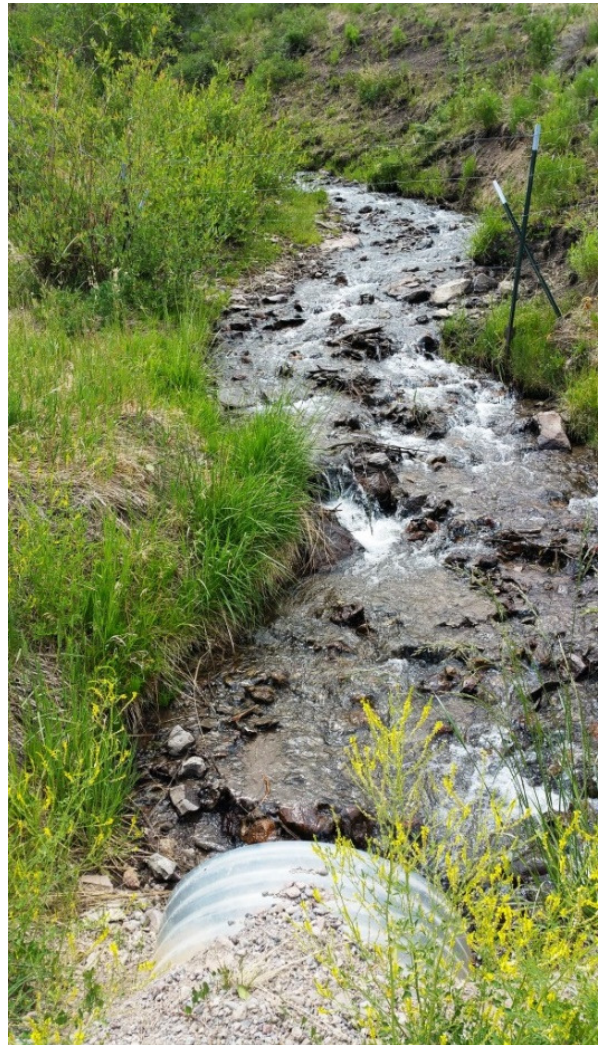
At the Beaver Creek diversion, the Town diverts the water from Beaver Creek into a side channel that runs the water over a “grizzly”, which screens out the larger rocks and some debris and into a trough. The first section of the trough includes a swing gate that can either direct the water directly into the Ridgway Ditch and/or divert some or all of the flow into a side channel that serves as both an overflow and rock chute. Spring water is also diverted into the Ridgway Ditch in various locations.

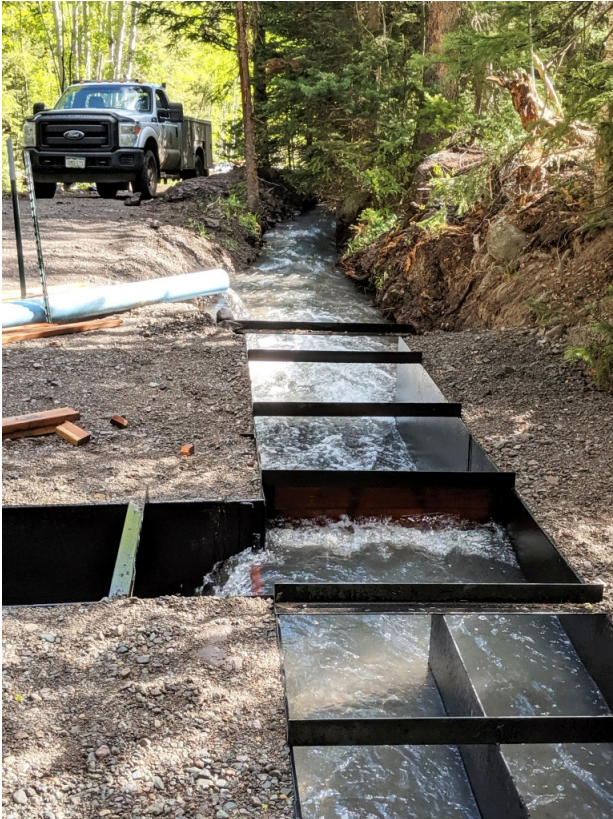
## II. A. Upgrades

The old trough was likely constructed in the mid to late 1970's is largely made of what was rough sawn lumber. The photos on page 10 show some of the reasons the trough was rated beyond its useful life. The wood on the floor of the trough had been worn down by the rocks and gravel running over the wood. Large storm events and time have allowed water to get behind the trough and time also caused the wood to warp. The old trough was replaced in the fall of 2018. The new trough is about 40% larger capacity to about 10 cfs, using a conservative n-value of about 0.03, which is far more than the capacity of the Ridgway Ditch (staff intends to check in 2019, but it is thought to be between 4-5 cfs in the most restrictive sections). The rock chute was designed to work as both a rock chute and overflow channel. The existing chute which already has a capacity of about 20 cfs, is now increased to about 25 cfs. The design for the new trough is included in the appendices. This new design should have a 50-year life.

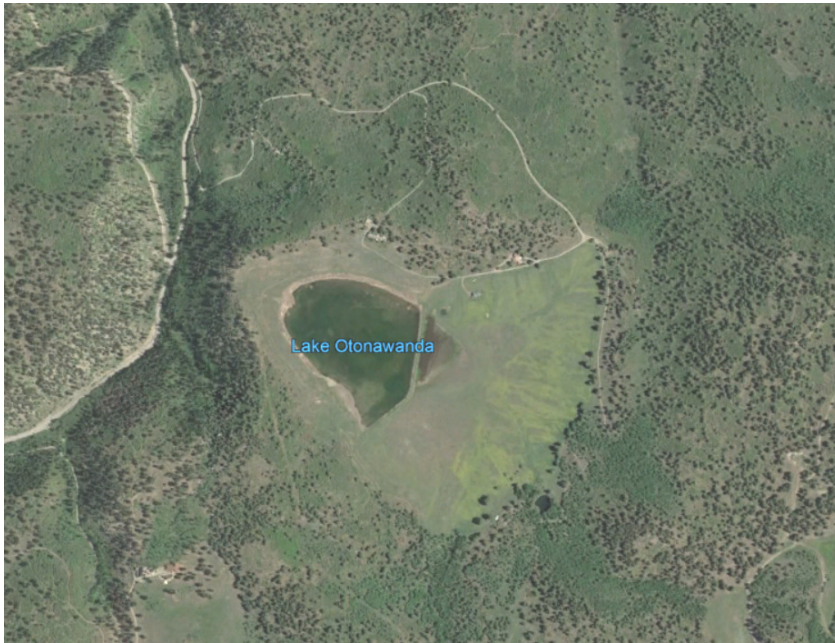
Lake Otonowanda is a raw water reservoir located on Miller Mesa off County Road 5 in a natural depression. The Town acquired the reservoir site consisting of about 39.4 acres in 1936. As originally configured the Town owned only a portion of the natural depression, so to confine town water on town property, a dam was built on the east and southern sides of the Town property. Water from Beaver Creek

is routed to Lake Otonowanda through an open ditch called the “Ridgway Ditch”. The original outlet from the Town's reservoir is thought to have been a tunnel that went through the saddle off the northwest side of the reservoir. The photo insert is the original lake. In 2015 the Town acquired an additional 28.531 acres to the east of the dam in the photo, expanding the storage capacity of the lake to approximately 675 acre feet.

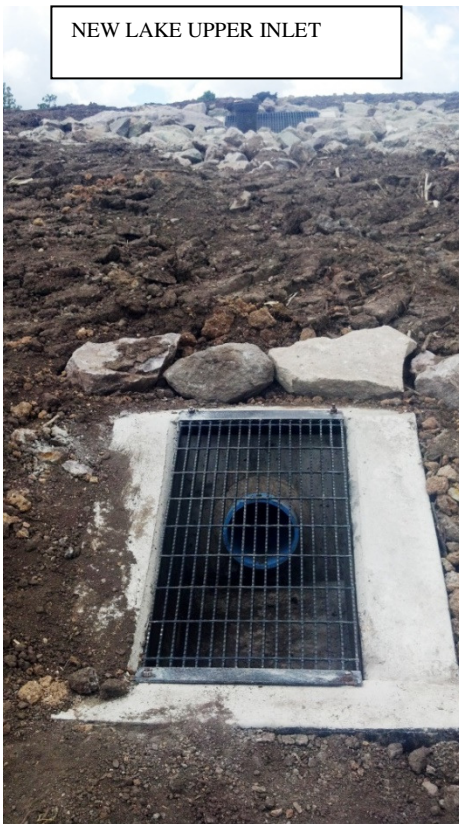
#### IV. A. Sediment

The 1985 facility assessment surveyed the lake from a rubber raft and tried to measure depth on a grid. The measurements at the time suggested the middle parts of the lake varied from 5-7 feet deep on top of the sediment. The bathymetric survey in 2009 was likely far more accurate. It found the depths of the lake to be 4-5+ feet deep. It is likely that between 1-2 feet of sediment has accumulated in the lake in 28 years between the assessments.

It is not likely cost effective to remove sediment in the near term. Dredging the older portion of the lake could remove the sediment, but it could also damage what seal is present on the lake bottom. As will be discussed below, keeping the lake from losing water via seepage may be a challenge especially if the existing seal is lost and not replaced, so keeping what seal is in place is important. In addition, with dredging, one needs to have a place to store or make use of the removed materials, or be prepared to pay extensive costs for removal and relocation of the significant amount of material that could be removed. Piping the ditch where it gains sediment is likely a better answer to controlling sediment going forward, as it should help reduce the rate of sediment accumulation in the lake as well as potentially improving the water quality in the Lake.

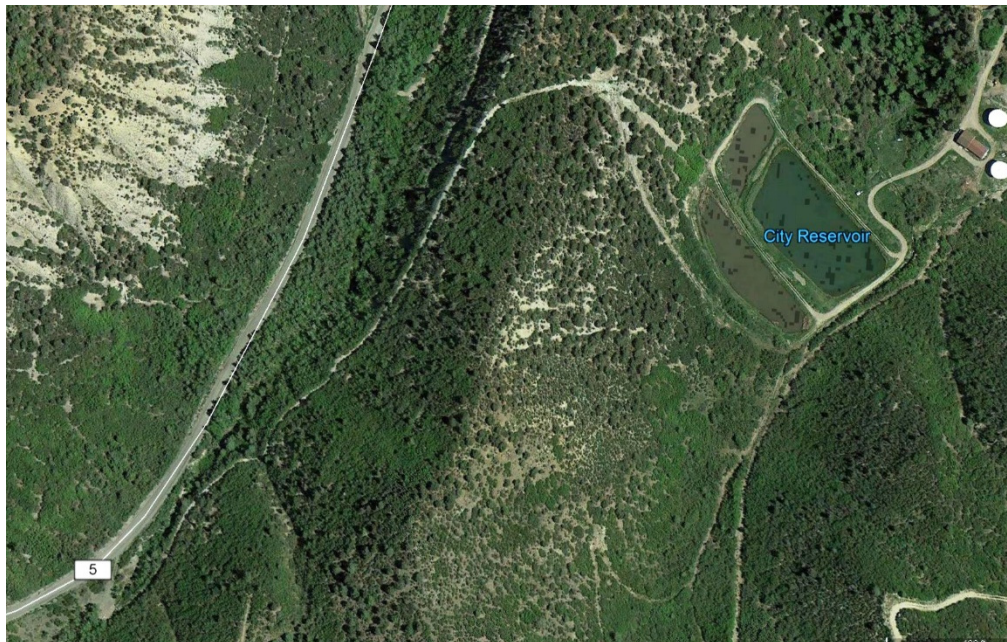
The Happy Hollow diversion is located on Cottonwood Creek about a mile south of town just off the east side of County Road 5. The Town and other water rights holder divert the water from the creek into Tidwell Ditch and then to their respective ditches. At the Town's split point, the Town's water is diverted into the Town's pipeline that flows to the pre-sedimentation ponds above the water treatment plant. The original design of the pipe discharged into the upper pre-sedimentation pond very close to the outlet from

that pond. A number of years ago, the Town staff modified the piping to allow the water from Happy Hollow flow to the "upstream" end of the upper pond to allow for more sediment removal. The Happy Hollow water tends to have less sediment and less chlorinated byproducts potential (Trihalomethanes (THM's) and Haloacetic acids (HHA5)) than the water from Beaver Creek or Lake O. Until recently the flows in Happy Hollow most of year were in the 0.3 - 0.5 cfs range. During the irrigation season, the Town

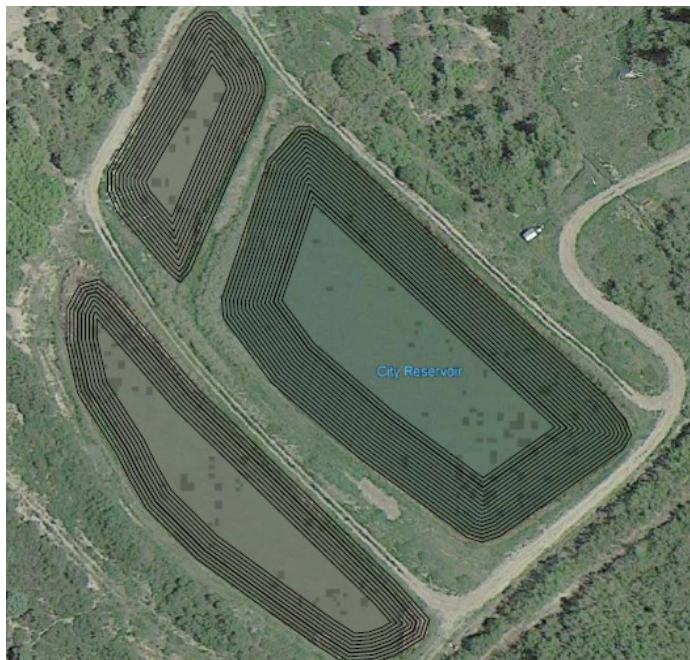
The 1980 drawings for the water system have an aerial photo of the pre-sedimentation ponds, but no volumes or depths. To determine the volume for this assessment, a scaled google earth image of the ponds was inserted into cad and the rough area of the high-water line was determined. The slopes were assumed to be 3:1 slope and the upper pond was assumed to be 8' deep which results in a volume of about 1.25 MG, the big pond was assumed to be functionally about 14' deep which results in a volume of about 3.8 MG and the small pond about 14' deep with a volume of about 0.57 MG and an overall volume of all ponds combined about 5.65 MG. If the assumptions about the slopes or depths are modified, the assumed volumes would change as they would if the surface area assumptions change. With a current peak demand of about 0.306 MGD treated and non-potable demand of about 0.5 cfs (0.323 MGD), detention time through the pre-sedimentation ponds in the summer is currently about 9 days.

As the Town's water demand increases, the detention time of the water in the ponds will decrease. It will also decrease if sediment increases. If total (potable and non-potable) water demand increases 50% in the next two decades, detention time in the pre-sedimentation ponds would drop to about 6 days in the summer if the current capacity is not reduced due to sediment build up. Given that most of the sediment seems to accumulate in the first part of the upper pond and the Town at times able to remove some of the accumulation, the reduction in detention time due to sediment may not be problematic in the next 10-15 years or so. Longer term, the Town might want to consider renovating the ponds. The pond area is mostly land locked with the ponds occupying most of the Town-owned land and they are also a bit topographically constrained in that there is a steep slope on the upstream side of the upper pond and a steep drop off the lower side of the big ponds. The most practical solution for expansion may be to increase the height of the dam southwest of the water plant and maybe to combine the larger and small pond. Options for renovation and capacity should be evaluated in greater detail when additional capacity is needed.

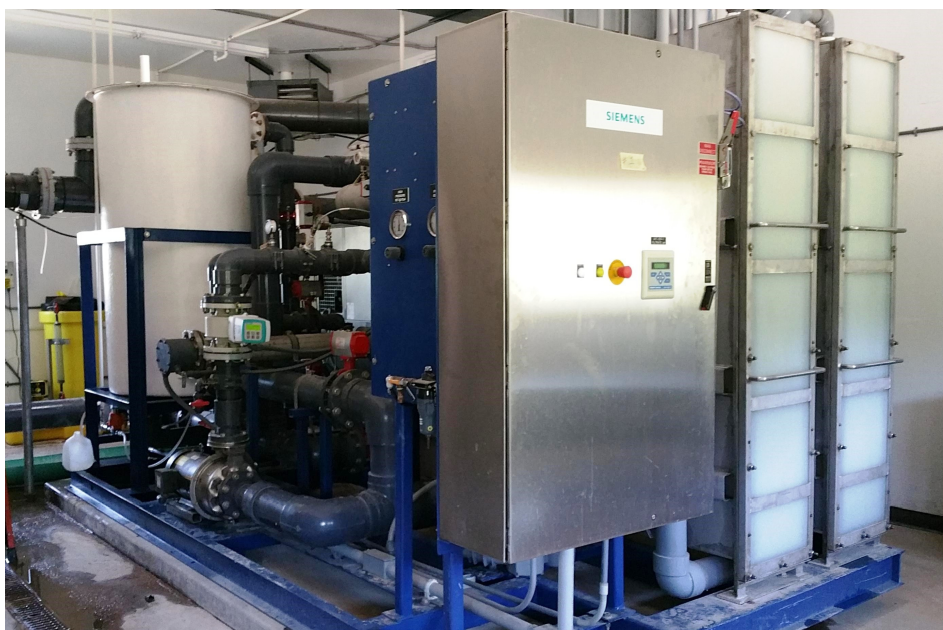
Following the addition of the chlorine dioxide to the raw water, the water flows into the microfiltration modules where particles in excess of about one micron are removed through a physical "straining" process. Following microfiltration, the water is disinfected with chlorine solution and flows to the water tank(s) for storage and chlorine contact time.

To keep performing efficiently, the microfiltration modules need to be backwashed regularly (typically about 30 minutes) and every few weeks they need to be deep cleaned in place (CIP) with concentrated chlorine solution or citric acid. Although Ridgway has not done so, other plants also use sodium hydroxide and hydrogen peroxide to restore modules that are clogged. The Town should check with the module supplier before trying any chemicals not specifically recommended for the Evoqua modules. Approximately 10% of the water produced is used to backwash and cleaning processes. Although the design capacity of the plant was specified to be a net of 500 gpm, i.e. 500 gpm going to the distribution system, the plant is closer to a gross of 500 gpm and net of about 450 gpm.

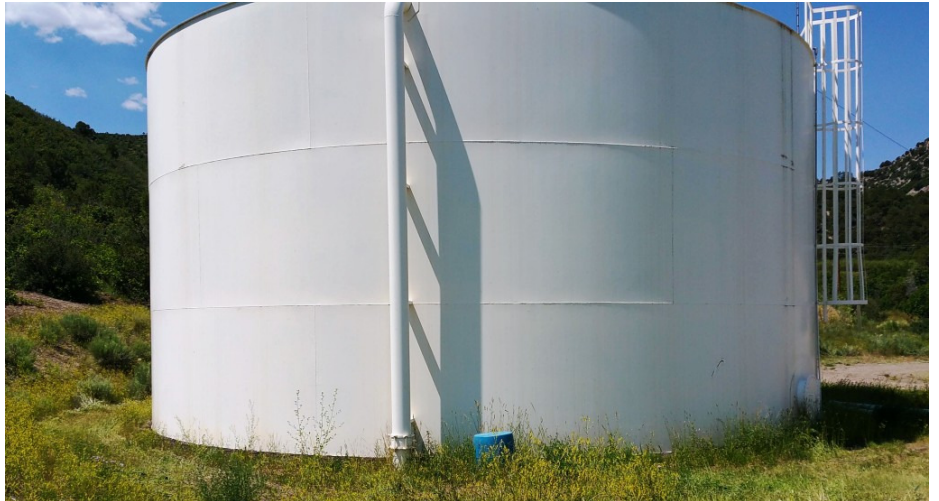
A 300,000 gallon 24' high water storage tank was constructed at the water plant site when the Culligan water plant was constructed as part of the 1980 water system replacement project. The Town added a second 300,000 treated water tank at the water plant site in 1992 along with piping that allowed the two tanks to run in series or parallel. The Town uses these storage tanks to provide chlorine contact time so bypassing one is allowable but bypassing both is not an option.

There is also a small, functionally approximately 18,000 gallon tank above the Vista Terrace Subdivision, east of Highway 550. This tank is set up to mostly serve the parts of Vista Terrace that are in the upper two pressure zones, which are the zones above the Vista Terrace pump station. The adequacy of storage east of the river is discussed below.

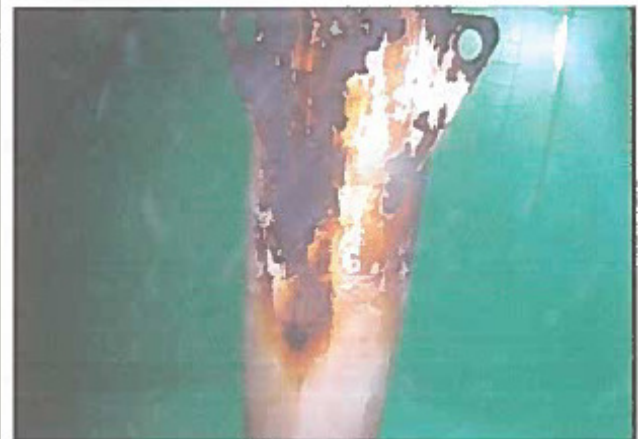
Most of the center column was in good condition, but there was significant damage to the coating where the water level fluctuates toward the top of the column. These were repaired in 2018. There was rusting at the rafters and at the connections between the rafters and the walls. The rafters on this tank are welded rather than bolted which is typically a better design. The video did not include a good look at these features. We recommend the next inspection do a thorough job of checking the roof system.

Overall the tank is in good condition with minor repairs needed as noted here. The Town should be setting aside reserves for a complete repaint of the tanks in approximately 10 years (2029).

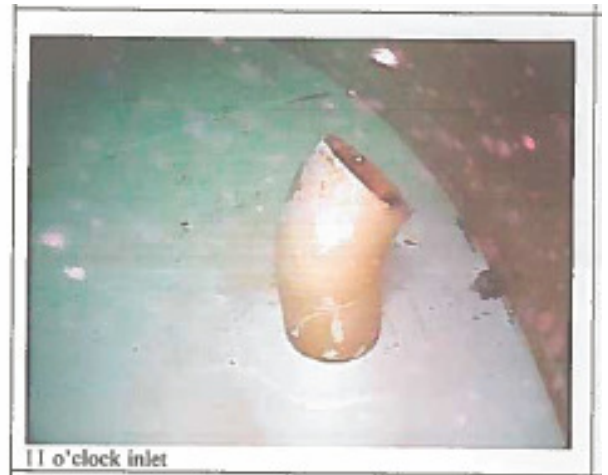
The inside ladder was in good to excellent condition, with some staining, and some rust nodules on ladder standouts. The top step was rusted with some tubercles. The float and target were not functional.

On the manway at 1:00, the outside welds have a little rust and there was rust on the edge of the 4" standout with a few rust nodules and blistering on the inside of the 4" insert. The other manway was reported to be in great condition. It was staining throughout, but no rust on the outside. The inside of manhole had some rust nodules as well.

The center column support had no rust on the base. It did have some staining and the wings (used to lift and set the column) had a little rust and delamination on the edges. The coating on the column was in very good condition from the tank floor to where the water level fluctuates. As is typical of tanks in our region, where the water level fluctuates, and ice surrounds the column as the water and ice go up and down, there was considerable damage to the coating system with surface corrosion and delamination.

Overall the tank is in good condition with minor repairs needed as noted here.
