CAPITAL ASSESSMENT REPORT:
Sewer Collection & Wastewater Treatment System

TOWN OF RIDGWAY

Final Report
April 30, 2019

Prepared by:
Consolidated Consulting Services
PO Box 1073
Ridgway, CO 81432

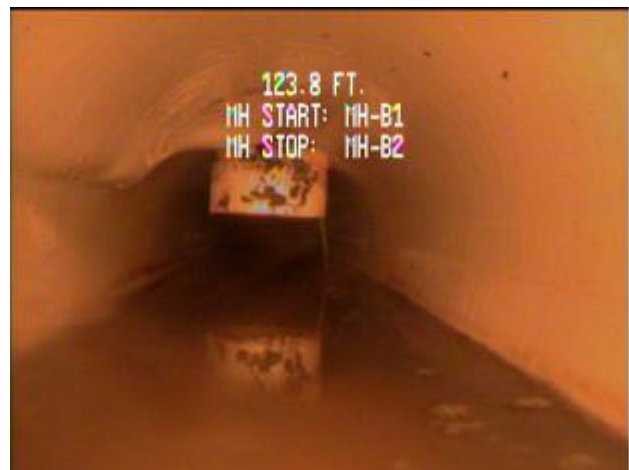
We also observed taps where a hole was cut into the pipe, the service pipe inserted in the hole and there appears to be "rub-r-nek" wrapped (an elastomeric sealant used to seal manhole sections) around the connection then backfilled. With this type of tap, there is no physical connection of the service pipe to the main so the service line can push into the main and become an intruding tap as shown at right. This is the worst type of tap because of the lack of physical connection which allows for intrusion of dirt and roots, and because the tap pipe intrusion can interfere with cleaning and videoing of the line. There were not many intruding taps found on the Ridgway system but those observed are listed in Table WW-1. This one above is on Lena between Otto and Frederick and should be repaired before this section of Lena Street is paved. This repair is also planned and budgeted in 2019.

As with the main line pipe, providing good bedding and compaction to support each service connection is important. If the connection is not properly supported and protected by the compacted bedding, stress or rocks can damage the connection during the trench backfill. Some service connections showed stress cracks indicating they were not properly bedded. Although the camera cannot see very far up the service line, if the service line is not properly bedded and compacted, it too can experience pipe indents and even pipe breaks.

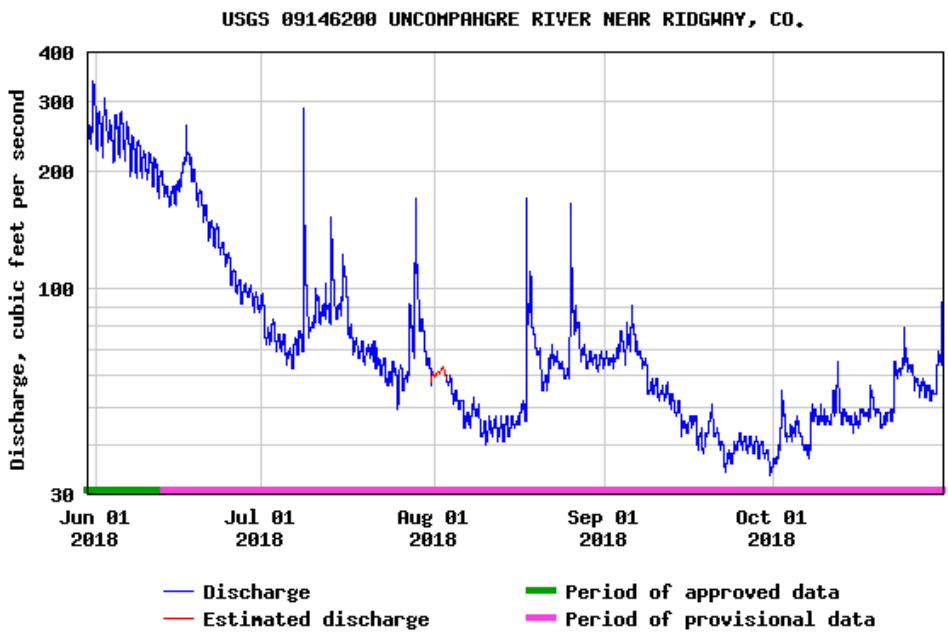
In 2013 when the last permit was issued, CDPHE determined that low flow in the river was 36 cfs using the CDPHE DFLOW model for the period from 2001 to 2013 as measured at the stream gauge upstream of Ridgway Reservoir. That resulted in a dilution of 120:1. Note that DFLOW provides a more conservative flow than the actual flows directly measured. Given the record-breaking low flows in the Uncompahgre in 2018 (see at left), if CDPHE uses

the 2018 data, the dilution could drop below 100:1 and require a site-specific permit; however, even a dilution of a little less than 100:1 is a reasonable amount of dilution and water-quality based effluent limits (WQBEL) might still not be needed. The permit writer at CDPHE would need to check, and the Town will want to confirm CDPHE's assessment. Parameters that would be evaluated for potentially more stringent limits if dilution is less than 100:1 include ammonia,

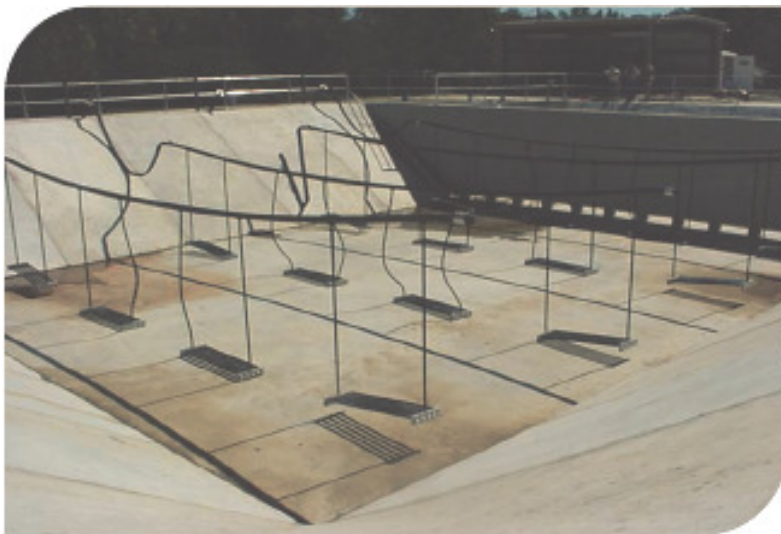
Because it did not require draining the cells, the Town requested pricing and design calculations for a proprietary Biolac system from Parkson. The Biolac system consists of diffusers suspended in the water from a cable system (see left). Air is delivered through air lines that are part of the support system. The system requires blowers to supply the air for the diffusers and if one wants to provide air based on oxygen demand in the lagoon one needs to include a dissolved oxygen monitoring system to the improvements package. The 2016 cost estimate for the equipment to convert all 3 cells to a Biolac system was in the \$400,000 range.

As part of the investigation to try to reduce power consumption at the plant, staff looked into a few kinds of sub-surface aeration that used fine-bubble diffusion, which has more efficient oxygen transfer into the water column thus requiring less water depth. Because draining the cells to install air lines and diffusers on the cell floors seems impractical and could result in damage to the earthen and/or synthetic liners, staff focused on aeration systems that could be installed without draining the cells.

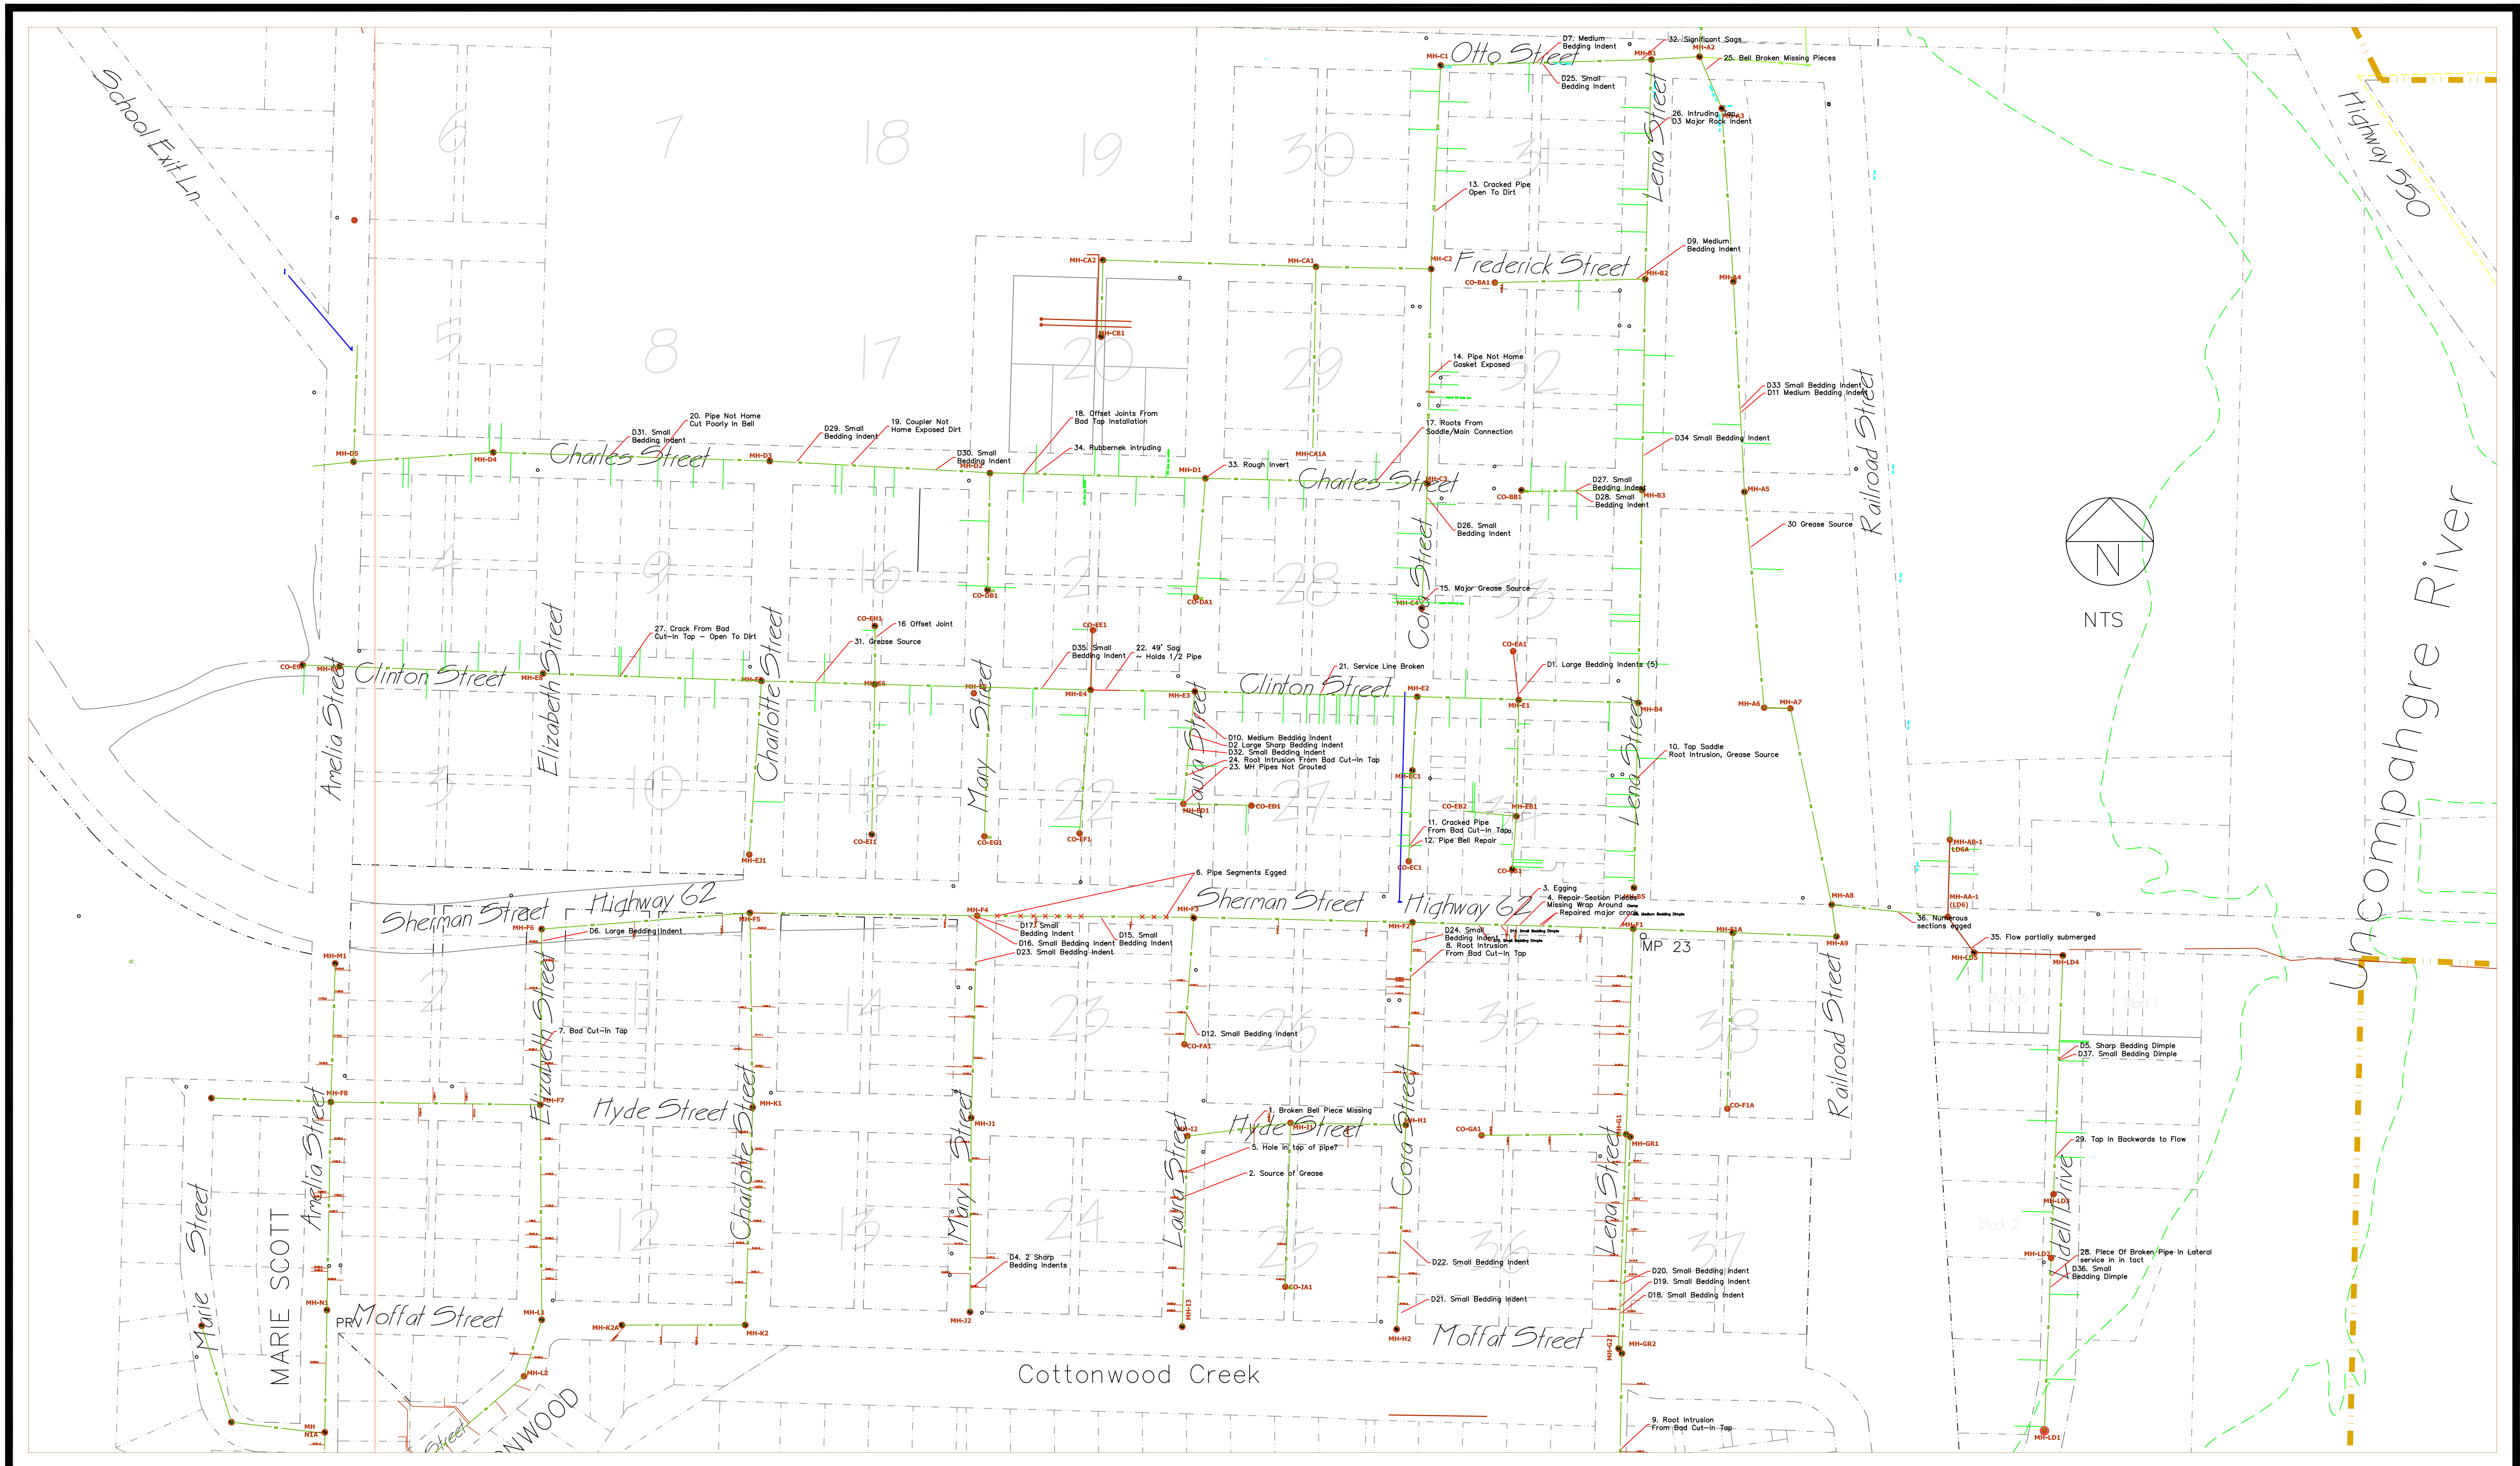
Figure WW-1
Sewer Line Deficiencies

Tables WW-1 is an itemized list of the issues with the collection system except the pipe indents. It includes the location, nature of the deficiency, a ranking of the severity, a priority for repair and estimated costs to repair. Each of these issues is shown in Figure WW-1. Table WW-2 lists locations where improper bedding has caused the pipe to be dented. Table WW-3 is a comprehensive list of the all the sewer lines that has been video inspected and a condition summary of each inspected line.

The collection system is relatively new and many of the lines are in adequate condition; however, it is apparent that the installation may not have been as good as one would have liked for long-term performance and serviceability of the system. There are a number of service connections that are generally in poor condition, creating a source of root infiltration into the Town's system. From the video review, there were not large sections of mains that need total replacement, however there are areas where spot repairs are recommended, and some of these are planned in 2019. Several segments of the 12" and 8" lines installed with the 1974 project show signs of pipe egging, where the pipe is deformed due to poor bedding. One line on Sherman Street between Mary and Laura Streets has some extensive egging but is not quite to the point that it is breaking. There are also numerous sections where rocks against the pipe are causing indents of the pipe. The areas where dimpling (indents) of the pipe due to rocks outside of the pipe, could rupture over time, especially where the rocks are sharp and/or the dents are enough to obstruct flow or does not allow camera or cleaning equipment to get by. These should be fixed relatively soon. The smaller dimples should be monitored as over time as they may become worse as the soils settle around the pipe putting pressure on the pipe. The summary of the deficiencies lists a number of those recommended for repair (Table WW-5).

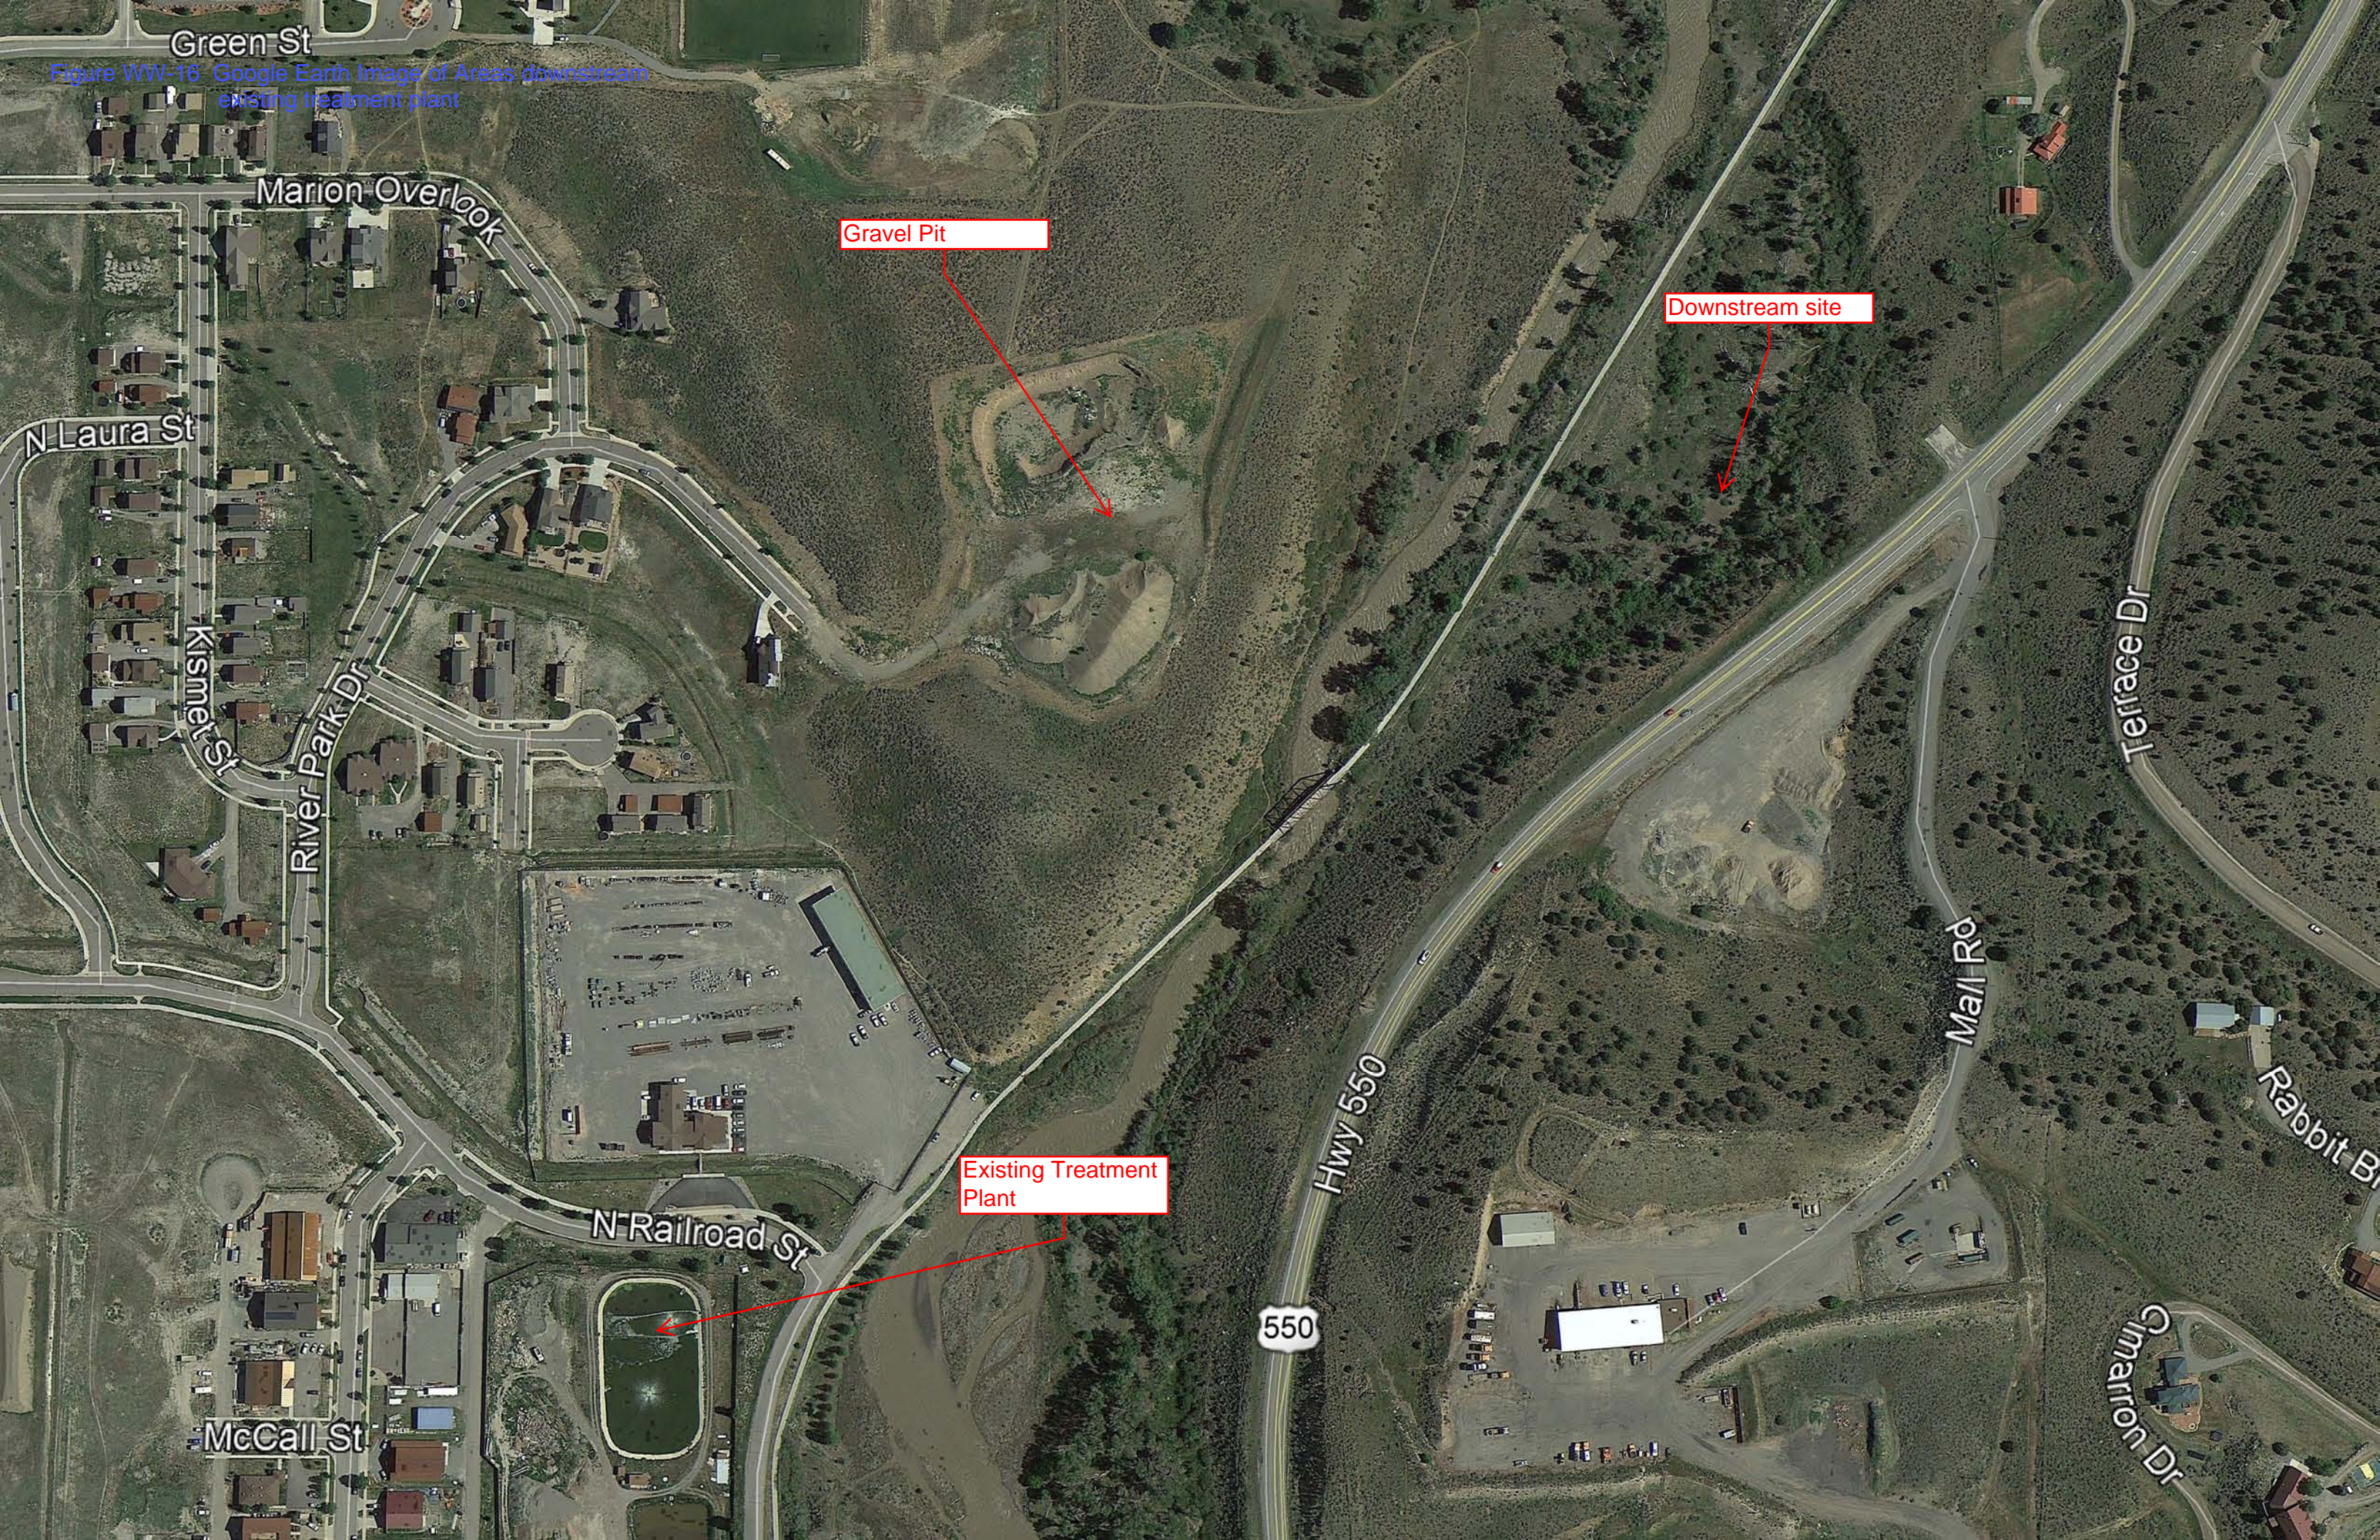
Figure WW-16 Google Earth Image of Areas downstream existing treatment plant

Gravel Pit

Downstream site

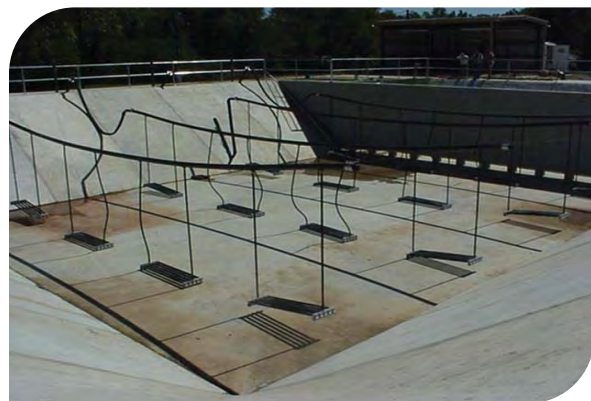
The aeration chain system is designed to be self-propelled and to move back and forth systematically in the wastewater to provide high mixing efficiency of the basin's content. This capability is critical to allow turndown flexibility in the aeration system while maintaining a completely mixed environment.

Air is delivered to each aeration chain from one side and connects to the air main through individual branches with butterfly valves. The butterfly valve provides individual control or isolation of the airflow to each chain.

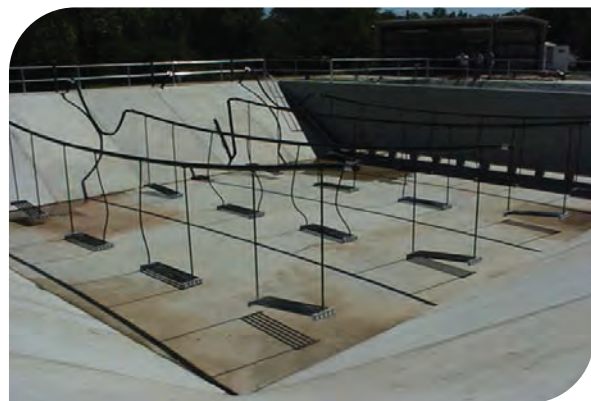
The aeration chain system is designed to be self-propelled and to move back and forth systematically in the wastewater to provide high mixing efficiency of the basin's content. This capability is critical to allow turndown flexibility in the aeration system while maintaining a completely mixed environment.

Air is delivered to each aeration chain from one side and connects to the air main through individual branches with butterfly valves. The butterfly valve provides individual control or isolation of the airflow to each chain.

The moving aeration chain is constructed of a single continuous polyethylene header. The moving aeration chain is connected to the Biofuser® by EPDM hose.
