CAPITAL ASSESSMENT REPORT: Water Treatment and Distribution System

TOWN OF RIDGWAY

Final Report
May 21, 2019

Prepared by:
Consolidated Consulting Services

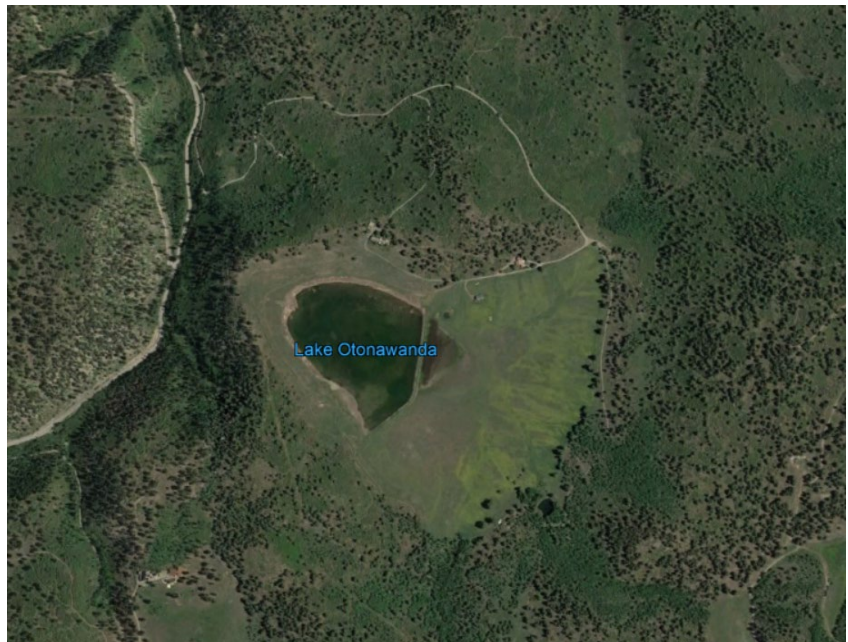
Lake Otonowanda is a raw water reservoir located on Miller Mesa off County Road 5 in a natural depression. The Town acquired the reservoir site consisting of about 39.4 acres in 1936. As originally configured the Town owned only a portion of the natural depression, so to confine town water on town property, a dam was built on the east and southern sides of the Town property. Water from Beaver Creek is routed to Lake Otonowanda through an open ditch called the "Ridgway Ditch". The original outlet from the Town's reservoir is thought to have been a tunnel that went through the saddle off the northwest side of the reservoir. The photo insert is the

original lake. In 2015 the Town acquired an additional 28.531 acres to the east of the dam in the photo, expanding the storage capacity of the lake to approximately **640 acre feet**.

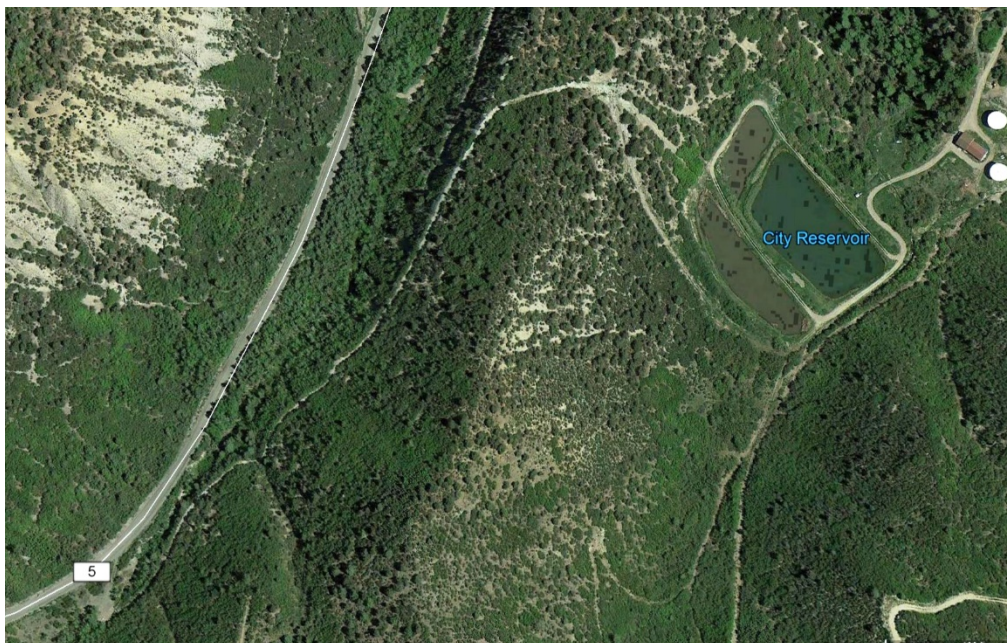
The Happy Hollow diversion is located on Cottonwood Creek about a mile south of town just off the east side of County Road 5. The Town and another water rights holder divert the water from the creek into Tidwell Ditch and then to their respective ditches. From the split point, the Town's water is diverted into the Town's pipeline that flows to the pre-sedimentation ponds above the water treatment plant. The original design of the pipe discharged into the upper pre-sedimentation pond very close to the outlet from that pond. A

A number of years ago, the Town staff modified the piping to allow the water from Happy Hollow flow to the "upstream" end of the upper pond to allow for more sediment removal. The Happy Hollow water tends to have less sediment and less chlorinated byproducts potential (Trihalomethanes (THM's) and Halo acetic acids (HHA5)) than the water from Beaver Creek or Lake O. Until recently the flows in Happy Hollow most of year were in the 0.3 - 0.5 cfs range. During the irrigation season, the Town shares the water with the irrigation user at the diversion. In the last few years, flows in Happy Hollow have increased where in the spring of 2017 and 2018, flows have been as high as 1 cfs, allowing the Town to operate the water plant with mostly Happy Hollow water. In 2017 the flows remained higher than normal most of the year, however, during the prolonged drought of the summer of 2018, flows dropped significantly and the Town needed to use water from Lake O in 2018 to meet the demand of the Town, even with mandatory water restrictions in place from June 12 – October 11, 2018.
