Technical Report

River Channel Characteristics of the Uncompahgre River in Ridgway, CO

SUBMITTED: 12/3/2021

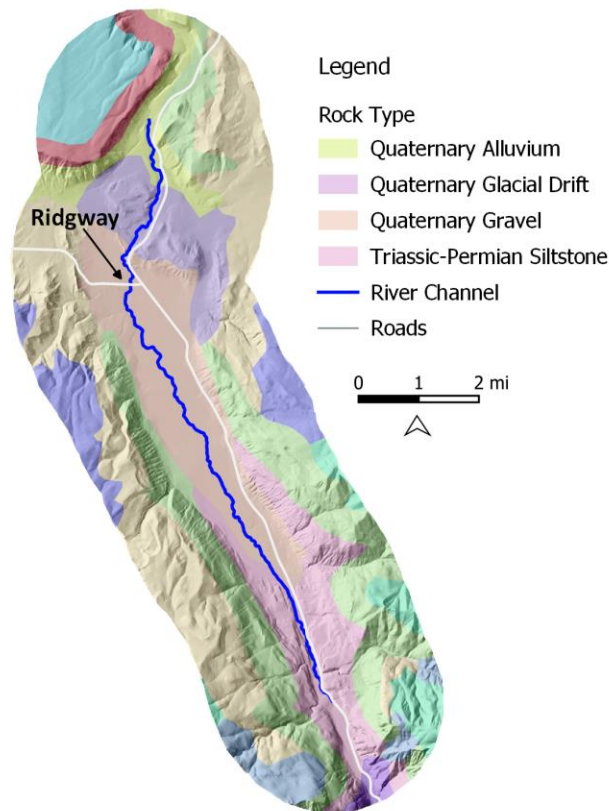
Figure 1. Surficial geology of the Uncompahgre River valley above Ridgway.

The Uncompahgre Valley and floodplain near Ridgway were deposited as a large alluvial glacial outwash plain at the slope of the San Juans. High sediment production in the river's headwaters occurred in previous, long-past geologic time periods due to mountain uplift, volcanic activity, and later subsequent mass-wasting and glacial activity. Steep headwaters were able to transport high sediment loads downstream out of the core range, then deposit them in wide floodplains. The Uncompahgre Valley upstream of Ridgway consists of deep alluvial gravel deposits resulting from this transport. Downstream of the town, in the vicinity of Dennis Weaver park, surficial geology shifts to glacial drift (unsorted glacial sediments), which have greater relief above the river but still provide relatively little long-term resistance to erosive forces on channel banks.

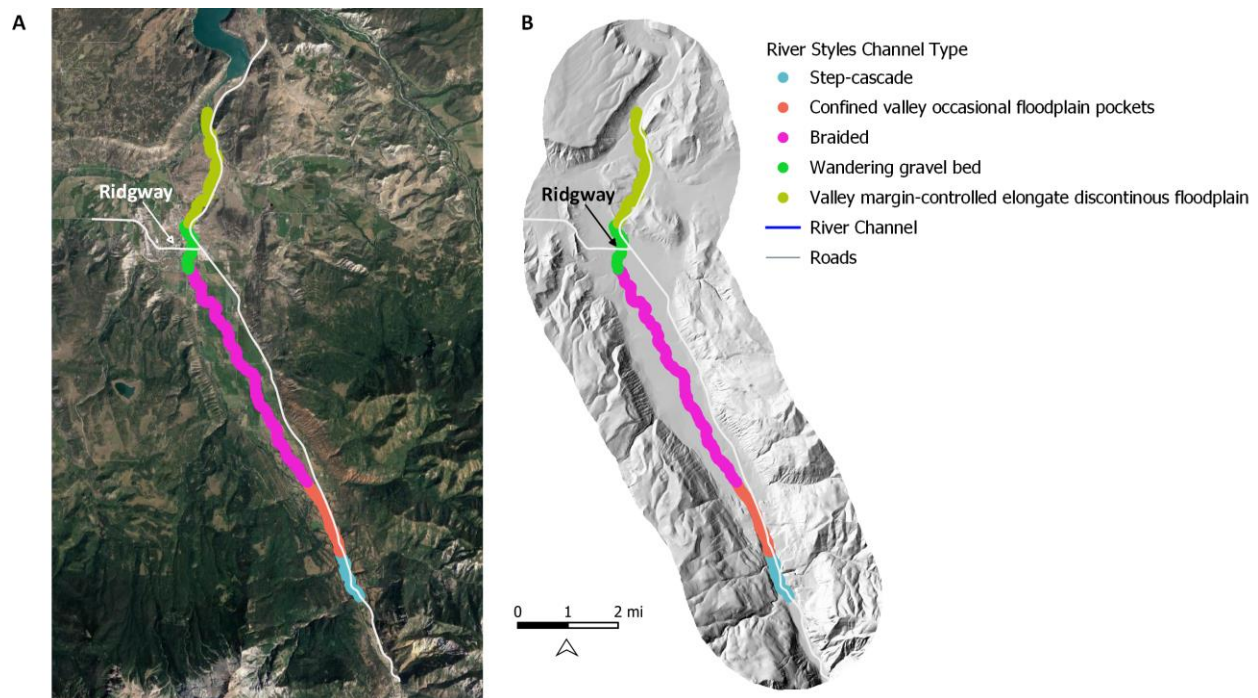
River segments above and through town are classified with *braided* and *wandering* channel types (Figure 3). These forms are often found on stream systems with high sediment loads and unconfined or partially confined valley margins. Numerous fluvial signatures (signs that a location was previously occupied or impacted by active river channel) are visible in the valley floor between Orvis Hot Springs and downtown Ridgway. The channel at this location underwent significant lateral movements ranging between 100-1000ft from its current course over time. Although the low-flow channel frequently makes a tortuous, pseudo-meandering path within its active channel corridor, the bankfull river channel is not highly sinuous and the plan form across the alluvial valley upstream of town is not fully meandering at any point. Several other channel forms were classified above and below the project area in confined valley reaches, but these are not relevant to issues on the downtown segment. Additional discussion of the characteristics of braided and wandering channel types, and their relevance for channel management in Ridgway, follows in Section 2.7.

Figure 3. River Styles channel classification map overlaid on aerial imagery (A) and shaded topography (B).

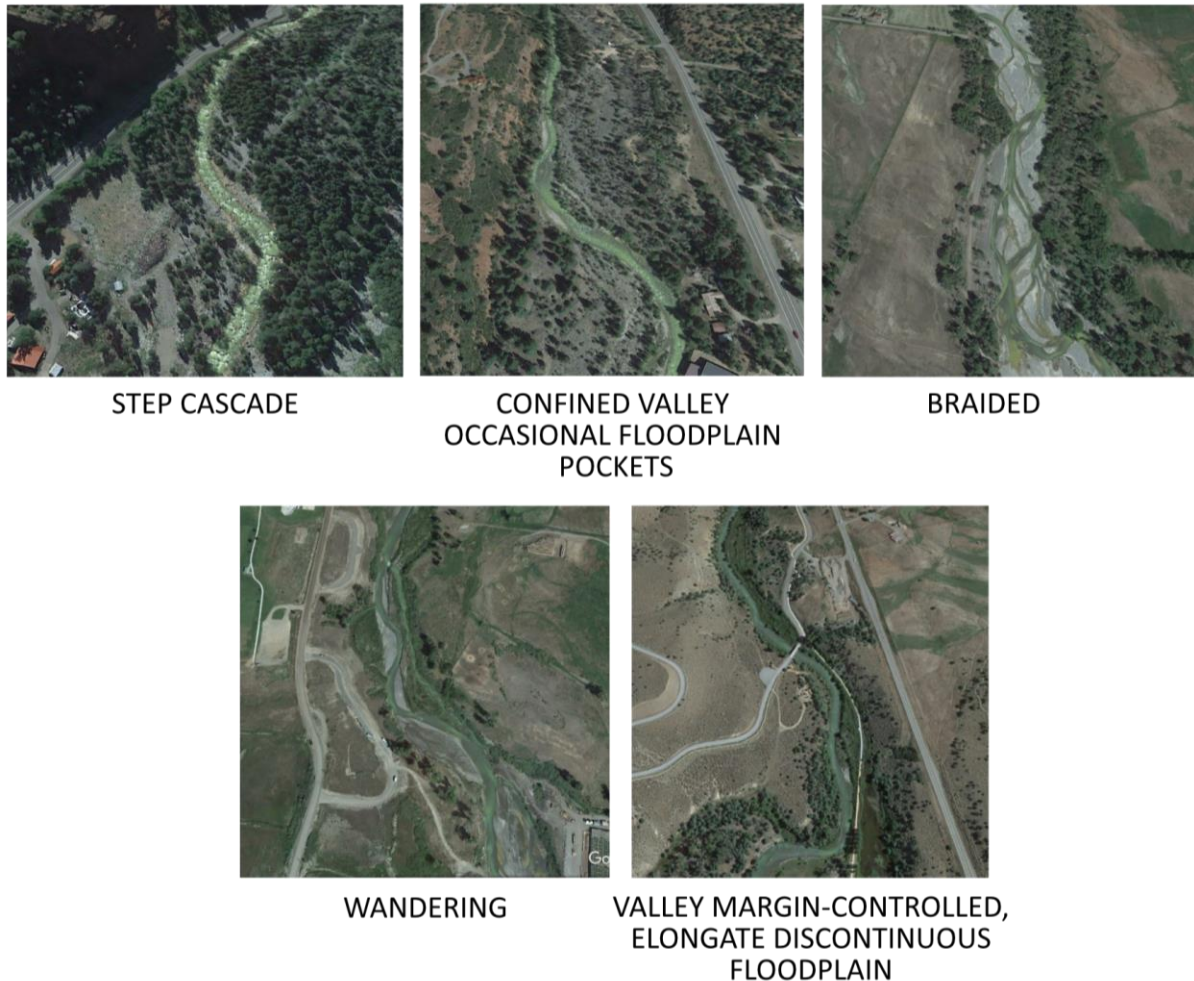
Figure 4. Example channel types observed in the Ridgway area.

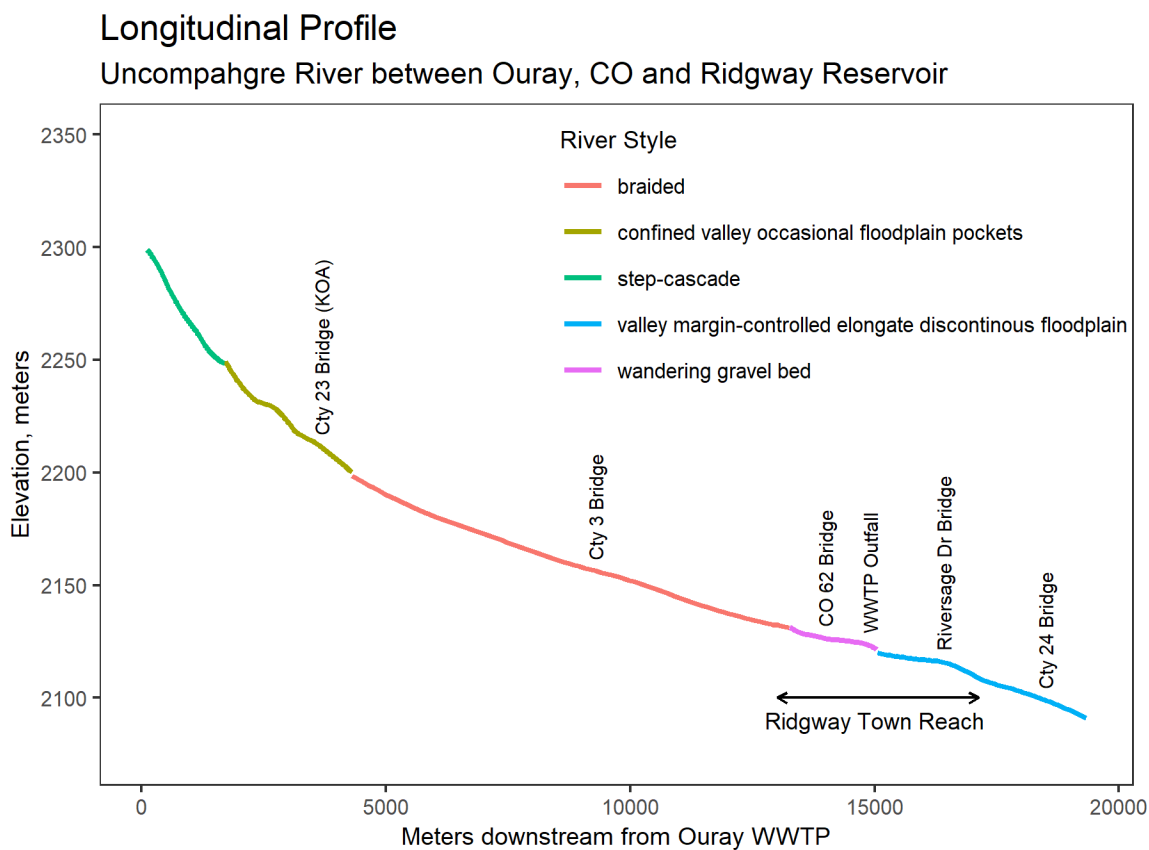
Figure 7. Longitudinal elevation profile of project area and upstream reaches.

Continual aggradation of the channel bed from upstream sediment causes the river to respond by continually moving its channel laterally, resulting in channel types ranging from meandering, to wandering, to braiding. These channel forms are evident upstream of Ridgway as the river leaves the steep confined downstream of Ouray. Near the County Rd 23 bridge and Ouray KOA campground, the river leaves this confined valley type and enters a wide alluvial gravel floodplain. A braided geomorphology is present here, characterized by multiple channel threads, constantly shifting gravel bars and chutes. Although braids are sometimes considered an 'unstable' form, they are actually a natural channel form that may be highly 'stable' on the landscape where sediment inputs and valley slope support their formation, such as mountain front alluvial outwash plains. In this setting, although the exact planform is constantly shifting, the overall channel type persists on the landscape over long timeframes.
